Longview Regional Water Treatment Plant Constructibility Study

The City of
Longview
Washington

May 7, 2008

Kennedy/Jenks Consultants
Engineers & Scientists

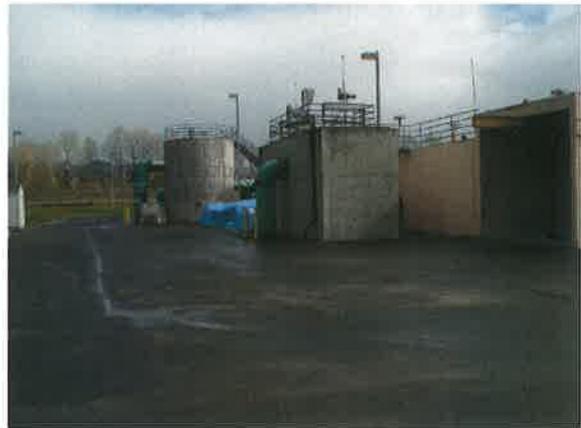
Photo No. 4 – Degritter and Rapid Mix Basin

The degritter and rapid mix basin structures are relatively new (installed in 1998), and the reinforced concrete and miscellaneous metals of the structures appear to be in good condition.

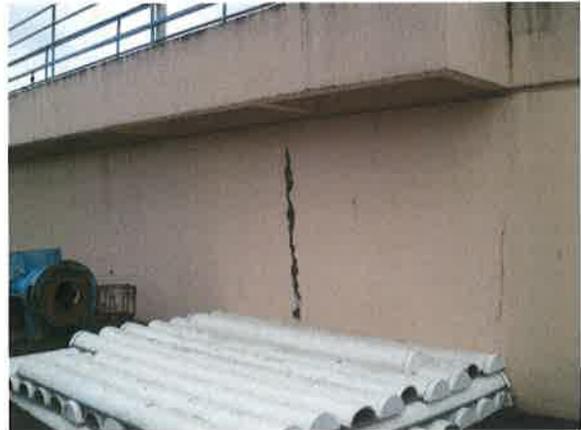
Photo No. 6 – Cracks and Spalls

Basin 1 was constructed as part of the 1979 expansion. Extensive cracking and some leakage were observed on the eastern side walls of both the flocculation (Photo 9) and sedimentation (Photo 6) basins. Vertical cracks were observed at regular intervals of 4 to 6 feet (Photo 10), portions of the cracks had spalled (Photos 7 and 8), and there was evidence of previous attempts to repair the cracks. Efflorescence in the cracks was also evident (Photo 11). Efflorescence is the deposit of salts, usually white, that forms on the surface after the salt has emerged from solution from within the concrete. Evidence indicated that the cracks have led to corrosion of the reinforcing steel in the walls; corrosion stains (Photo 10) were noted on the walls of the flocculation basin.

Basin 1 will reach the end of its useful life within the next 10 years. Over the next few years, the quantity and size of cracks, spalling and leakage of the tanks are expected to continue to increase as the corrosion cycle destroys the reinforcing steel in the walls of the basins, producing larger cracks, spalls and leakage from the basins.

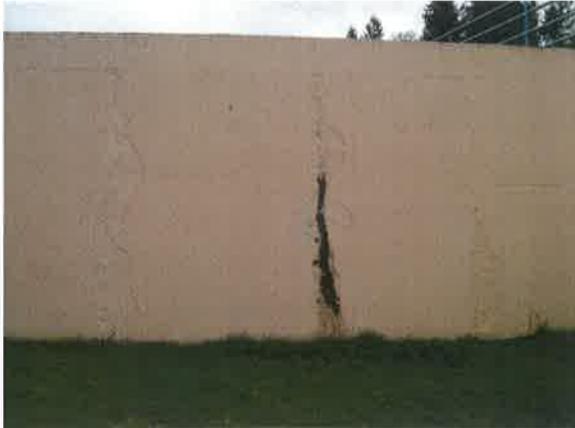
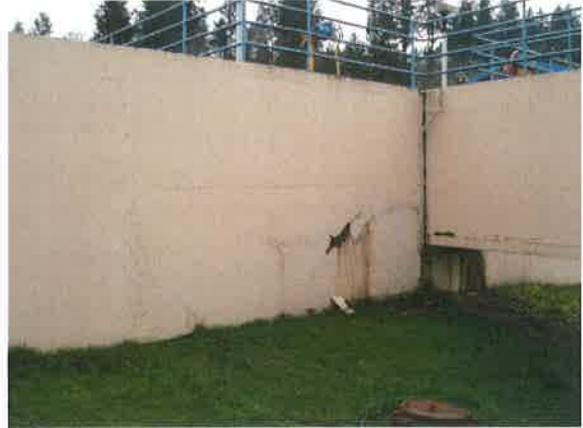
Kennedy/Jenks Consultants observed extensive cracking, spalling, and some leakage in the walls of the basin. Extensive cracking and spalling were observed beneath and along the sides of structural corbels supporting the channel that connect Basins 1 and 2 (Photos 13, 14 and 15). Extensive cracking, spalling, and leakage were also observed in the walls of Basin 2 (Photos 17 and 18).

The cracking, spalling, and leakage in these basin walls, as well as the history of unsuccessful attempts to repair the cracks in the walls, indicates that the walls of these structures have reached the end of their useful life. In addition, the walls of Basins 2 and 3 are extremely thin and contain reinforcement in size and spacing which, while acceptable for the hydrostatic loads when the basins were designed, would be considered severely deficient under current code requirements for environmental structures.
