# **WATER QUALITY UPDATE**

*February 20, 2014*

*Presented by:  
Amy Blain, Project Manager  
Melinda Friedman, Confluence Engineering Group, LLC*

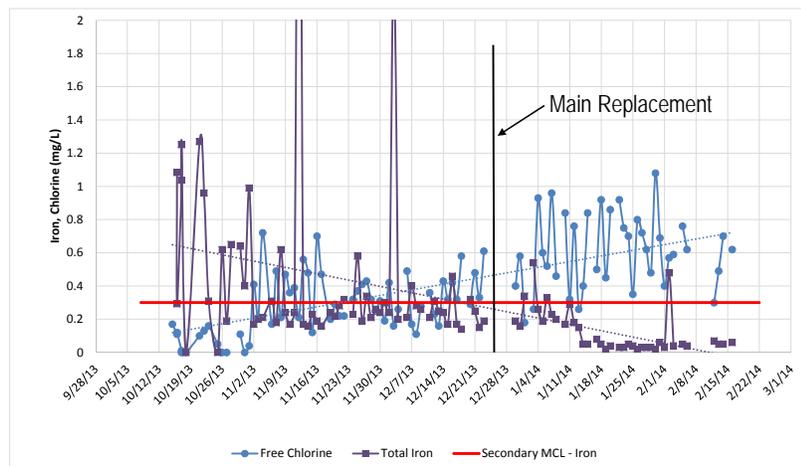
## Alley Main Between 16<sup>th</sup> and 17<sup>th</sup> Avenues

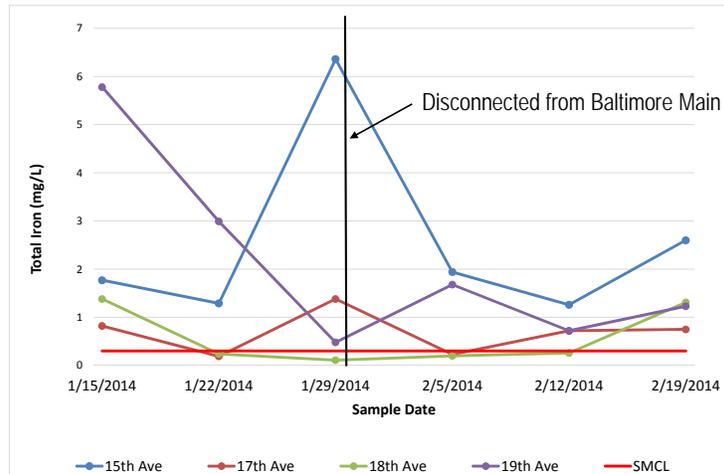
## Baltimore Area Water Quality (600 Block)

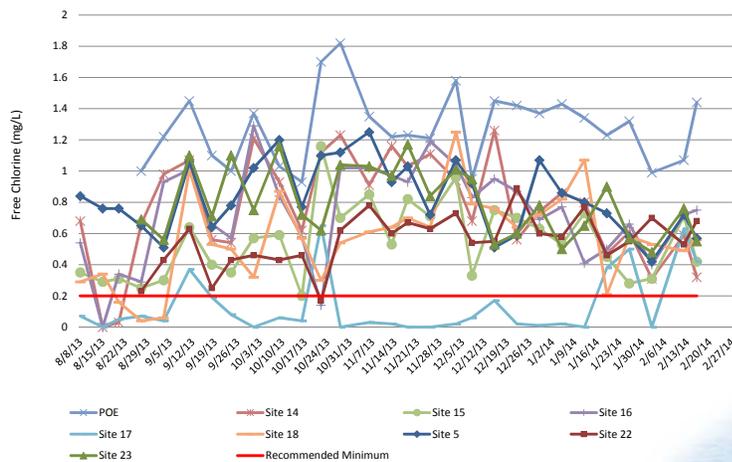
## Chlorine Residual Trends

- ▶ Ongoing distribution system sampling at 9 sites
  - Acceptable chlorine level at all areas except Site 17 – but improving in this area
  - Oxidation Reduction Potential (ORP) stabilized at all areas except Site 17 – but improving in this area
  - Mn level routinely at or below SMCL at all areas
  - Recent trends show fluctuations in iron and manganese, but this is due to lower chlorine and absence of flushing due to weather concerns
  - Test results indicate the distribution system can be stabilized

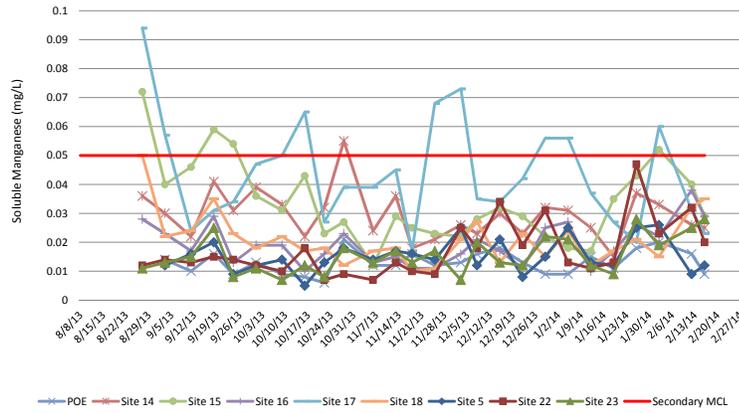
## Soluble Manganese Trends

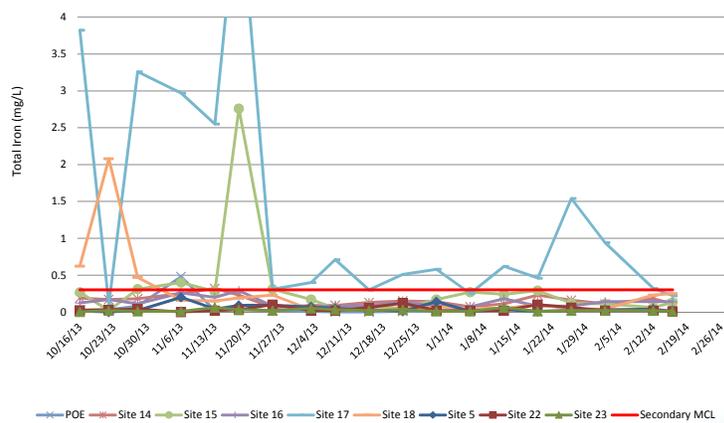
## Total Iron Trends

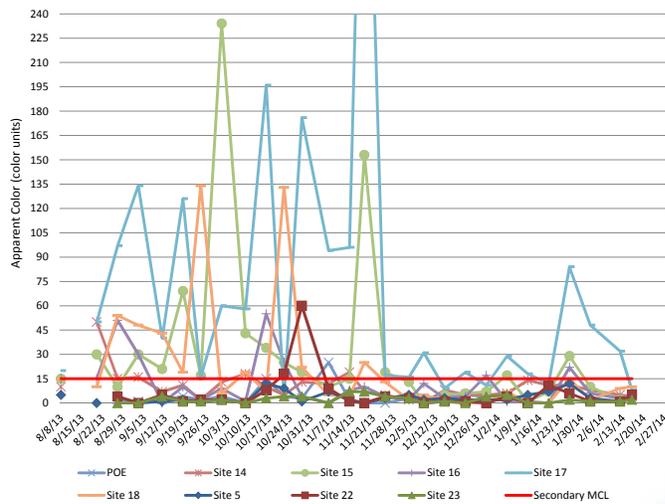
## Apparent Color Trends

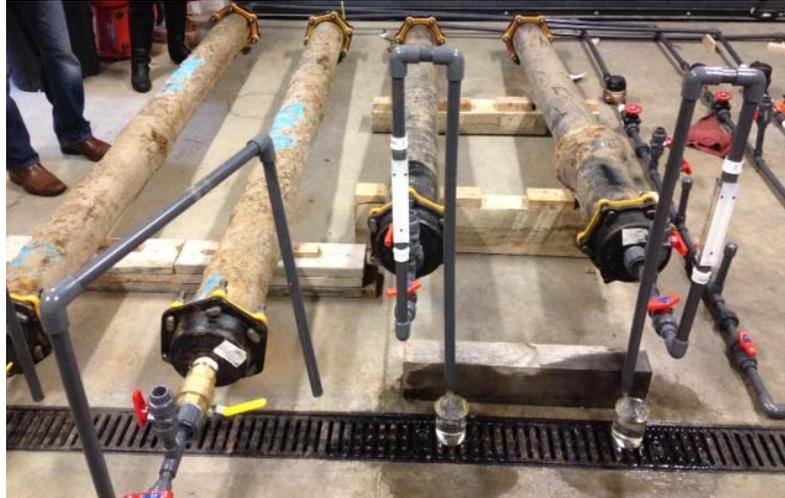
## Pipe Rigs

- ▶ **What is a pipe rig?**
  - **Small-scale distribution system used to study and understand the full-scale system**
  - **Assembled from existing pipes recently removed from the system**
    - Alley between 16<sup>th</sup> and 17<sup>th</sup>
    - Ocean Beach Hwy
  - **Water flows through the pipes, like in the real system**
  - **Different flow rates and stagnation times can be studied**
  - **Alternate chemical treatments could be evaluated**

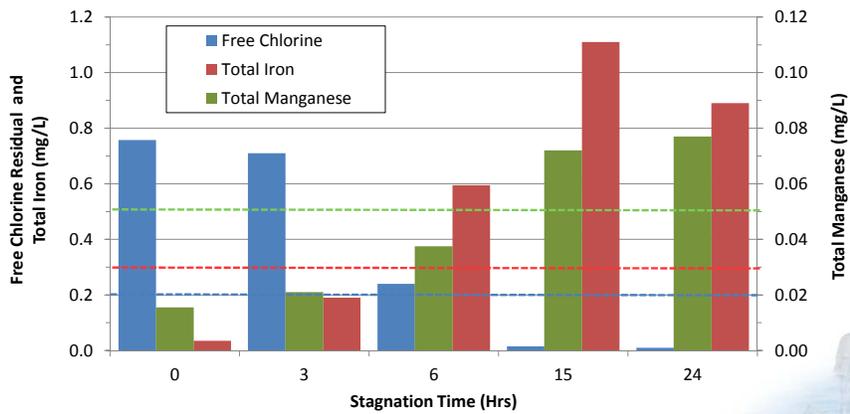
## Water Quality Degradation with Increasing Stagnation Time

- ▶ Chlorine residual (and ORP) dropped significantly, especially with more than 6-hours of stagnation
- ▶ High levels of iron and manganese were observed, due to loss of chlorine residual and ORP
- ▶ Water quality rapidly improved along with chlorine residual and ORP when freshly treated water flows through the pipe rig
- ▶ Results can be used to develop proactive guidelines for maintaining water quality throughout distribution system
  - Iron and manganese are controlled when chlorine  $\geq 0.6$  mg/L

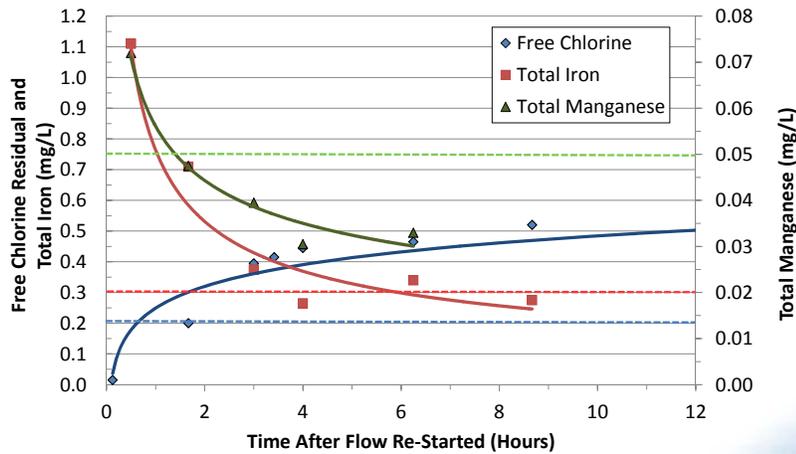
## Water Quality Recovery following 15-hr Stagnation

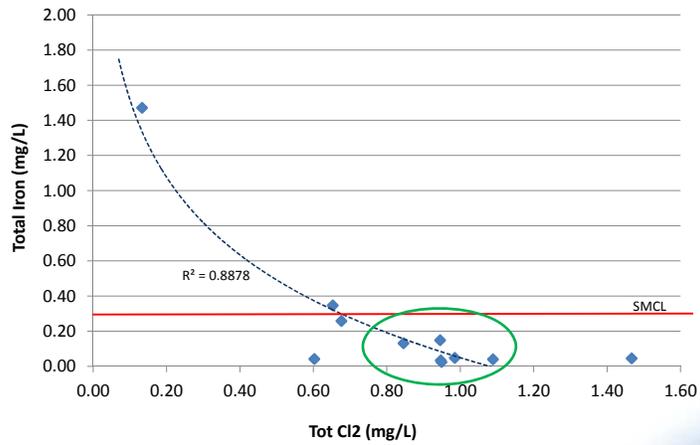
### Average Chlorine vs. Iron for On-going Distribution System Sites

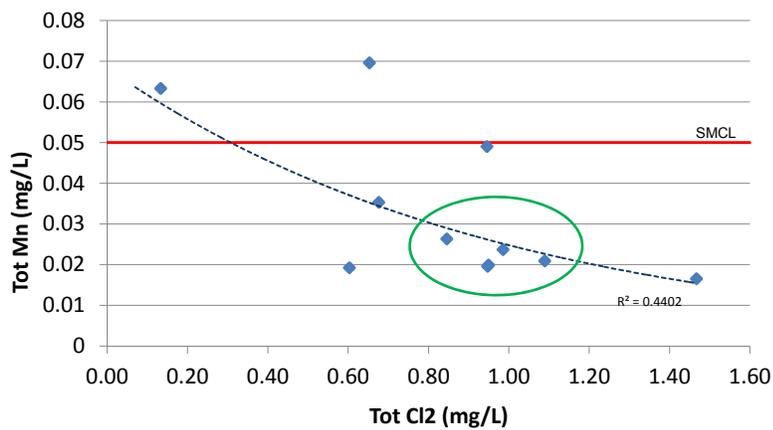
### Average Chlorine vs. Manganese for On-going Distribution System Sites

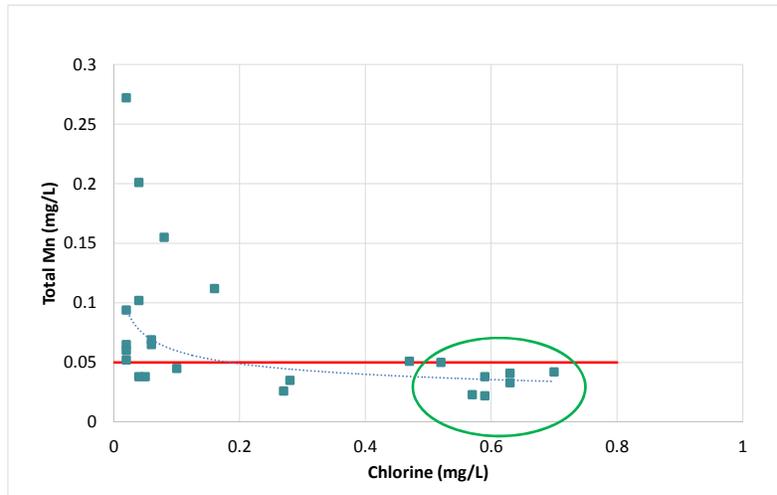
### Manganese Release Controlled when Chlorine $\geq 0.6$ mg/L - Area around 600 Block

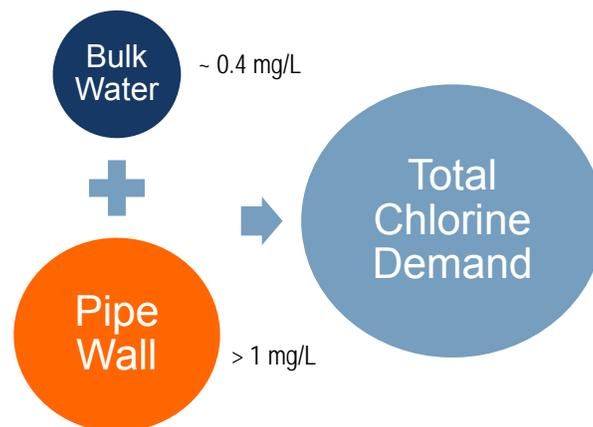
### Causes of Chlorine Demand (Chlorine Loss)

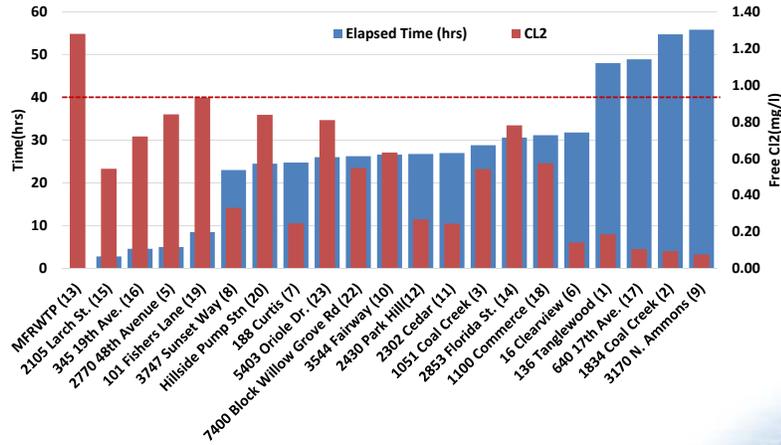
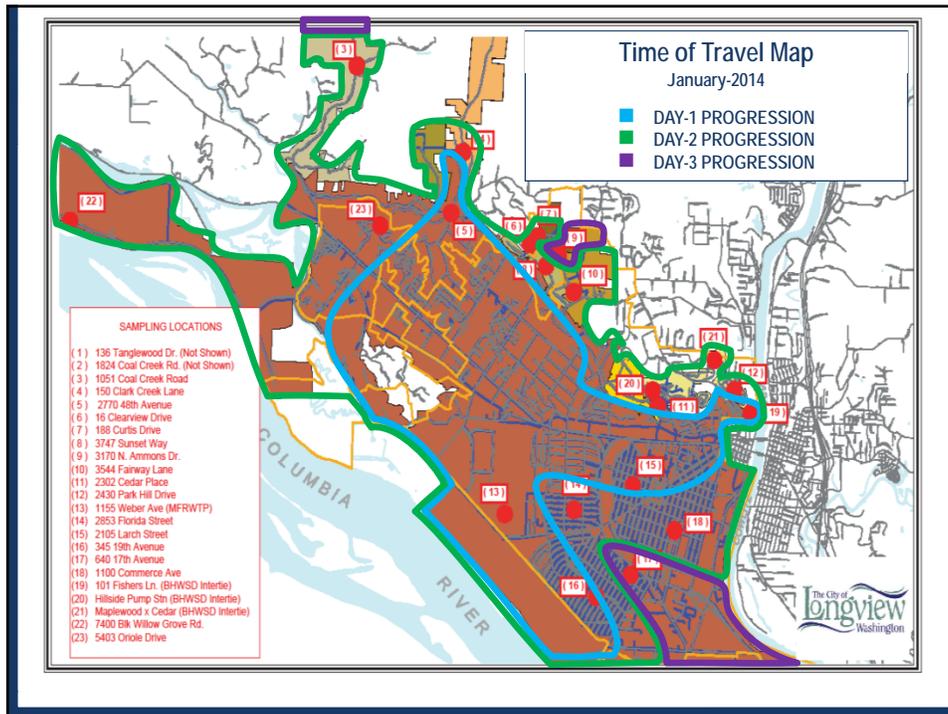
## Travel Time vs. Chlorine at Water Quality Locations

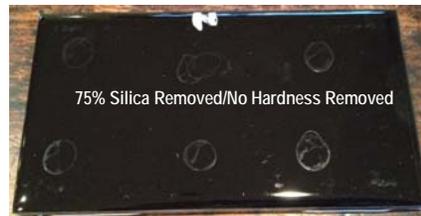
### Example Tile Spotting Results

- ▶ Compared spotting potential associated with different softening techniques
  - Ion exchange
  - Pellet softening
  - Lime softening
- ▶ Very little, if any, visual improvement observed with softening alone
- ▶ Visible improvement observed with 50% silica reduction
- ▶ Greatest improvement with 75% silica reduction

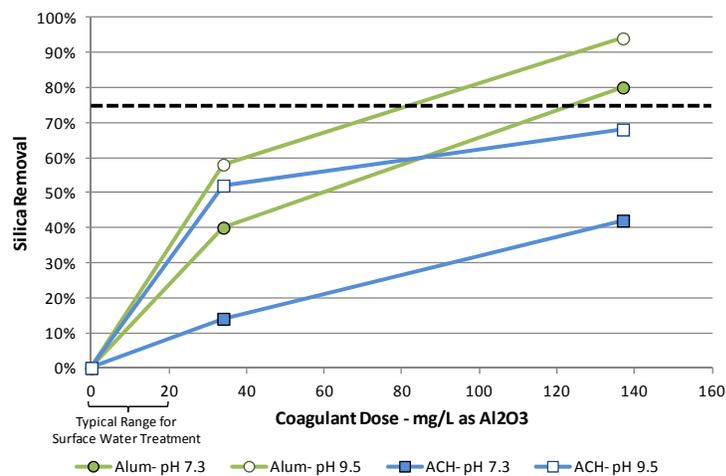
## Silica Co-Precipitation with Aluminum

- > 50% silica removal is attainable ... but full-scale process are very complex and expensive
  - Extremely high coagulant doses required
  - pH  $\uparrow$  9 before filters and  $\downarrow$  7.7 after filters
  - Aluminum chlorohydrate (ACH) needed to keep Total Dissolved Solids, Sulfate, and Aluminum below their SMCLs
  - Hardness is also reduced during the silica removal process

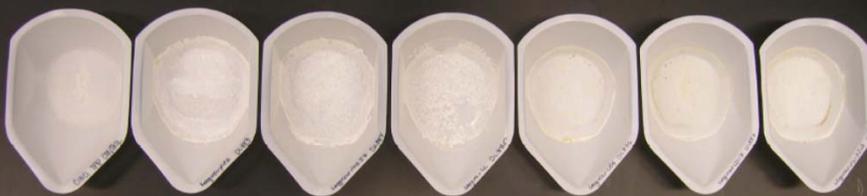
## USEPA Office of Research and Development Spotting Analysis

Cincinnati Tap Water	Longview POE Water	Longview POE w/Phos.	Customer Control Area	Customer Problem Area	Site 17	Site 17 w/Phos.
----------------------	--------------------	----------------------	-----------------------	-----------------------	---------	-----------------

pH	8.5	pH	7.7
Ca	34.7	Ca	26.4
Mg	10.4	Mg	5.8
Na	26.2	Na	18.0
Cl	27.6	Cl	26.3
SiO <sub>2</sub>	4.8	SiO <sub>2</sub>	50.0

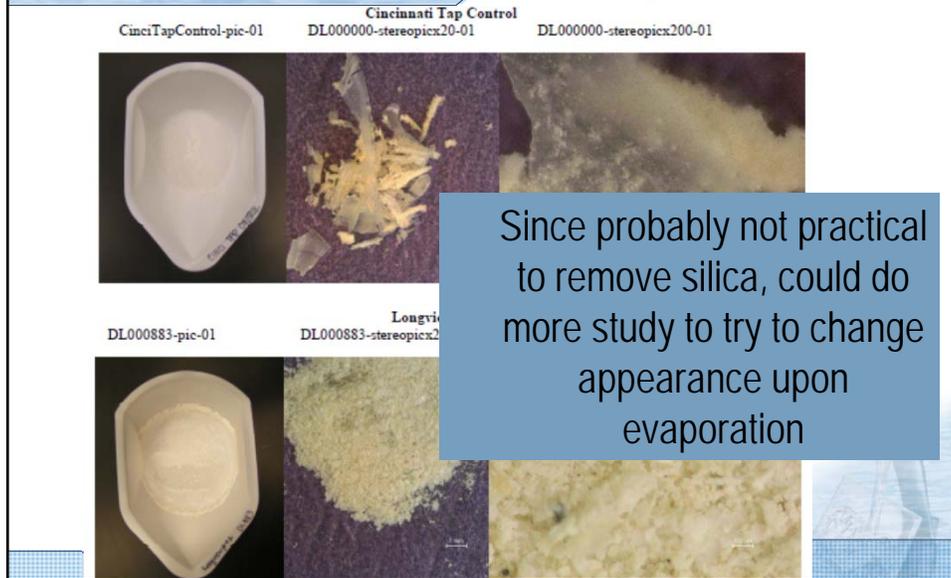
## Comparison of Solids Formed

- ▶ **Primary cause of white spotting has been identified**
  - **Primarily associated with naturally-occurring silica, not hardness or other dissolved solids**
    - CaCO<sub>3</sub> chemistry does not support precipitation
    - Qualitative visual comparison
    - USEPA solids analyses (preliminary)
  - **Evaporative process, no evidence of accumulation in distribution system**
- ▶ **Softening not likely to make significant improvement**
- ▶ **Silica removal very complex and expensive**
