EVALUATION

2.1 CONDITION ASSESSMENT

City of Longview Lake Sacajawea Park Preservation Plan

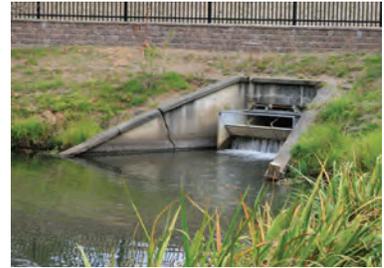
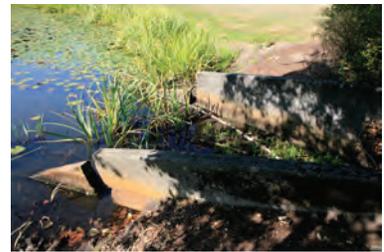
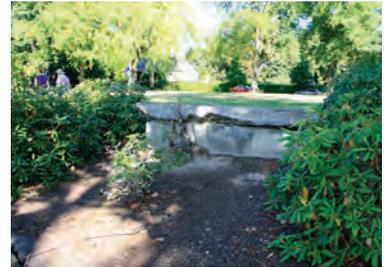
Cracked outlet walls

Several of the outlet gate wing walls exhibit cracking and spalled concrete. These walls are designed to keep the outflow from eroding the bank. Generally they are still able to do this, but as the cracked pieces settle and move out of alignment this capacity will diminish.

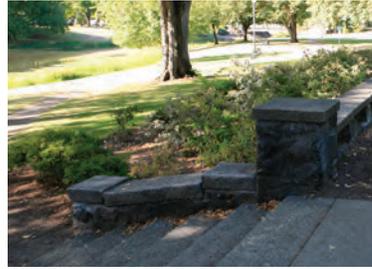
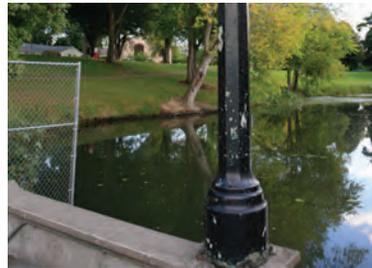
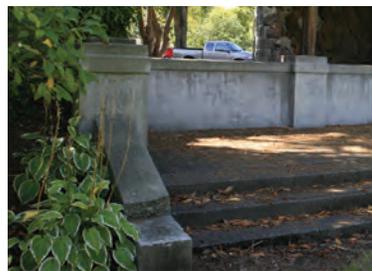
ISSUE	DESCRIPTION
Loose Copings	The basalt wall exhibits several loose concrete copings.
Paint Deterioration on Light Standards	The historic light fixtures on Lion's Island exhibit paint deterioration.
Missing Features	The retaining wall in the sunken garden exhibits some missing features along the lower wing walls.

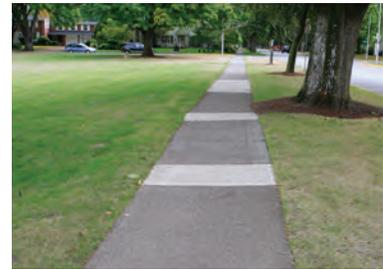
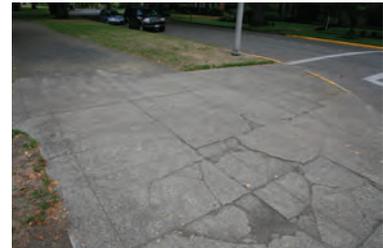
Cracked and broken concrete walkways

Original concrete sidewalks exhibit areas of cracking. Previous repairs to concrete walkways have not always replicated the original concrete type and tooling. These repair areas stand out noticeably from the darker gray of the original concrete.

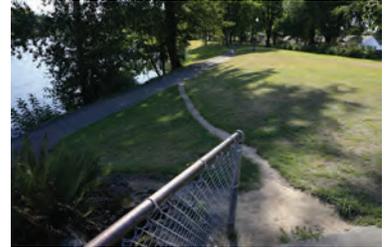
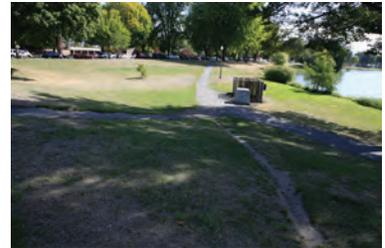
Added short-cut trails developed through repetitive use

Repetitive pedestrian use along the shortest routes between destinations led to development of trails. These typically occur at the bridge approaches between the gravel pathways along the lake and the concrete sidewalks along the streets. These trails encourage erosion of the topography through pedestrian traffic and storm water run off along the trails.

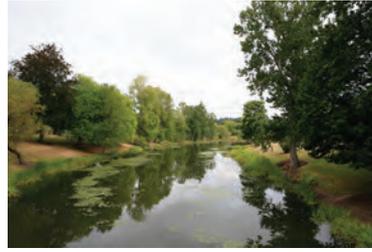
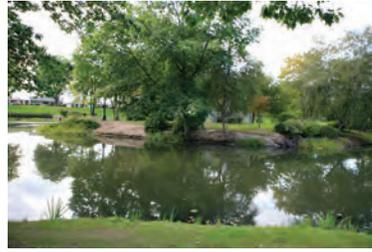
Shoreline erosion

Shoreline erosion presents a significant condition issue throughout the park. In the most severe locations the erosion has produced high banks that continue to sluff off along their tops. Comparison with the erosion locations with original drawings indicates some areas of erosion occur at locations that missing their originally designed shrub layer. The restoration of shrub and tree plantings could assist in reducing and arresting shoreline erosion.

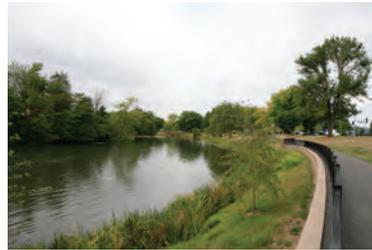
Added retaining walls

Added retaining walls throughout the park done in association with new pathways cut through the original topography. The downslope side presents an added complication for maintenance of the turf.

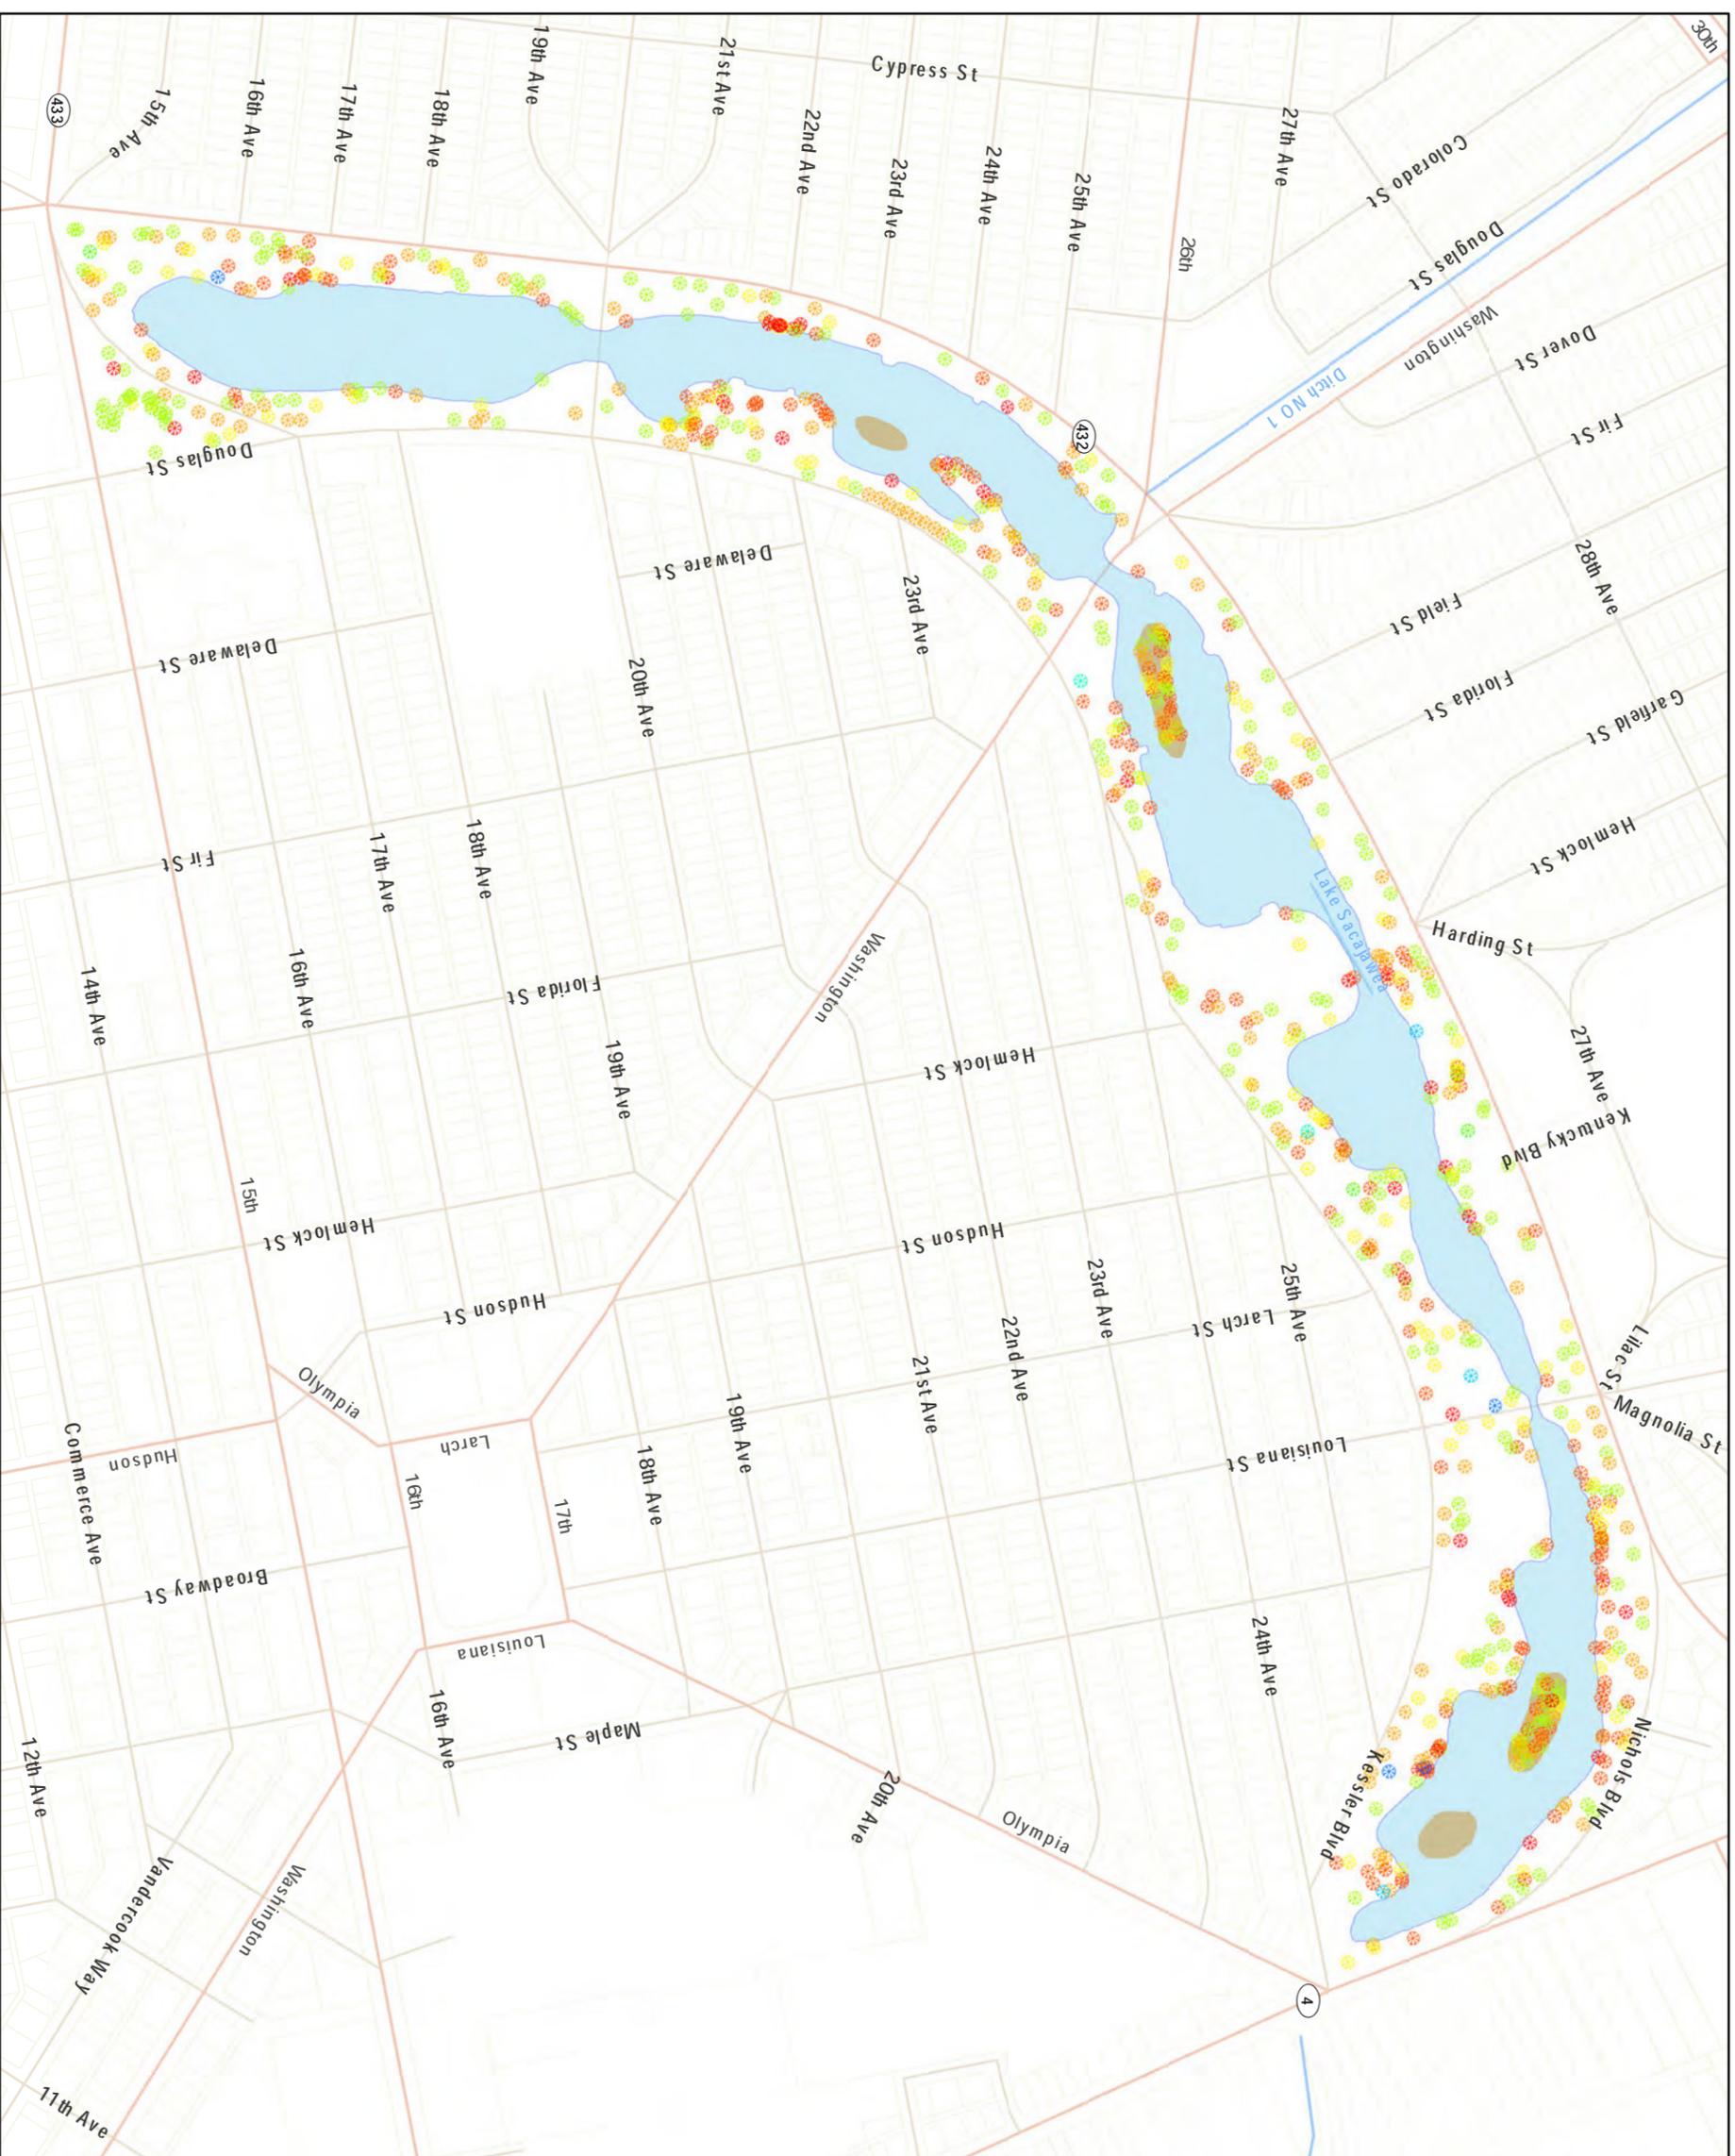
Tree Life Expectancy

As of 2010

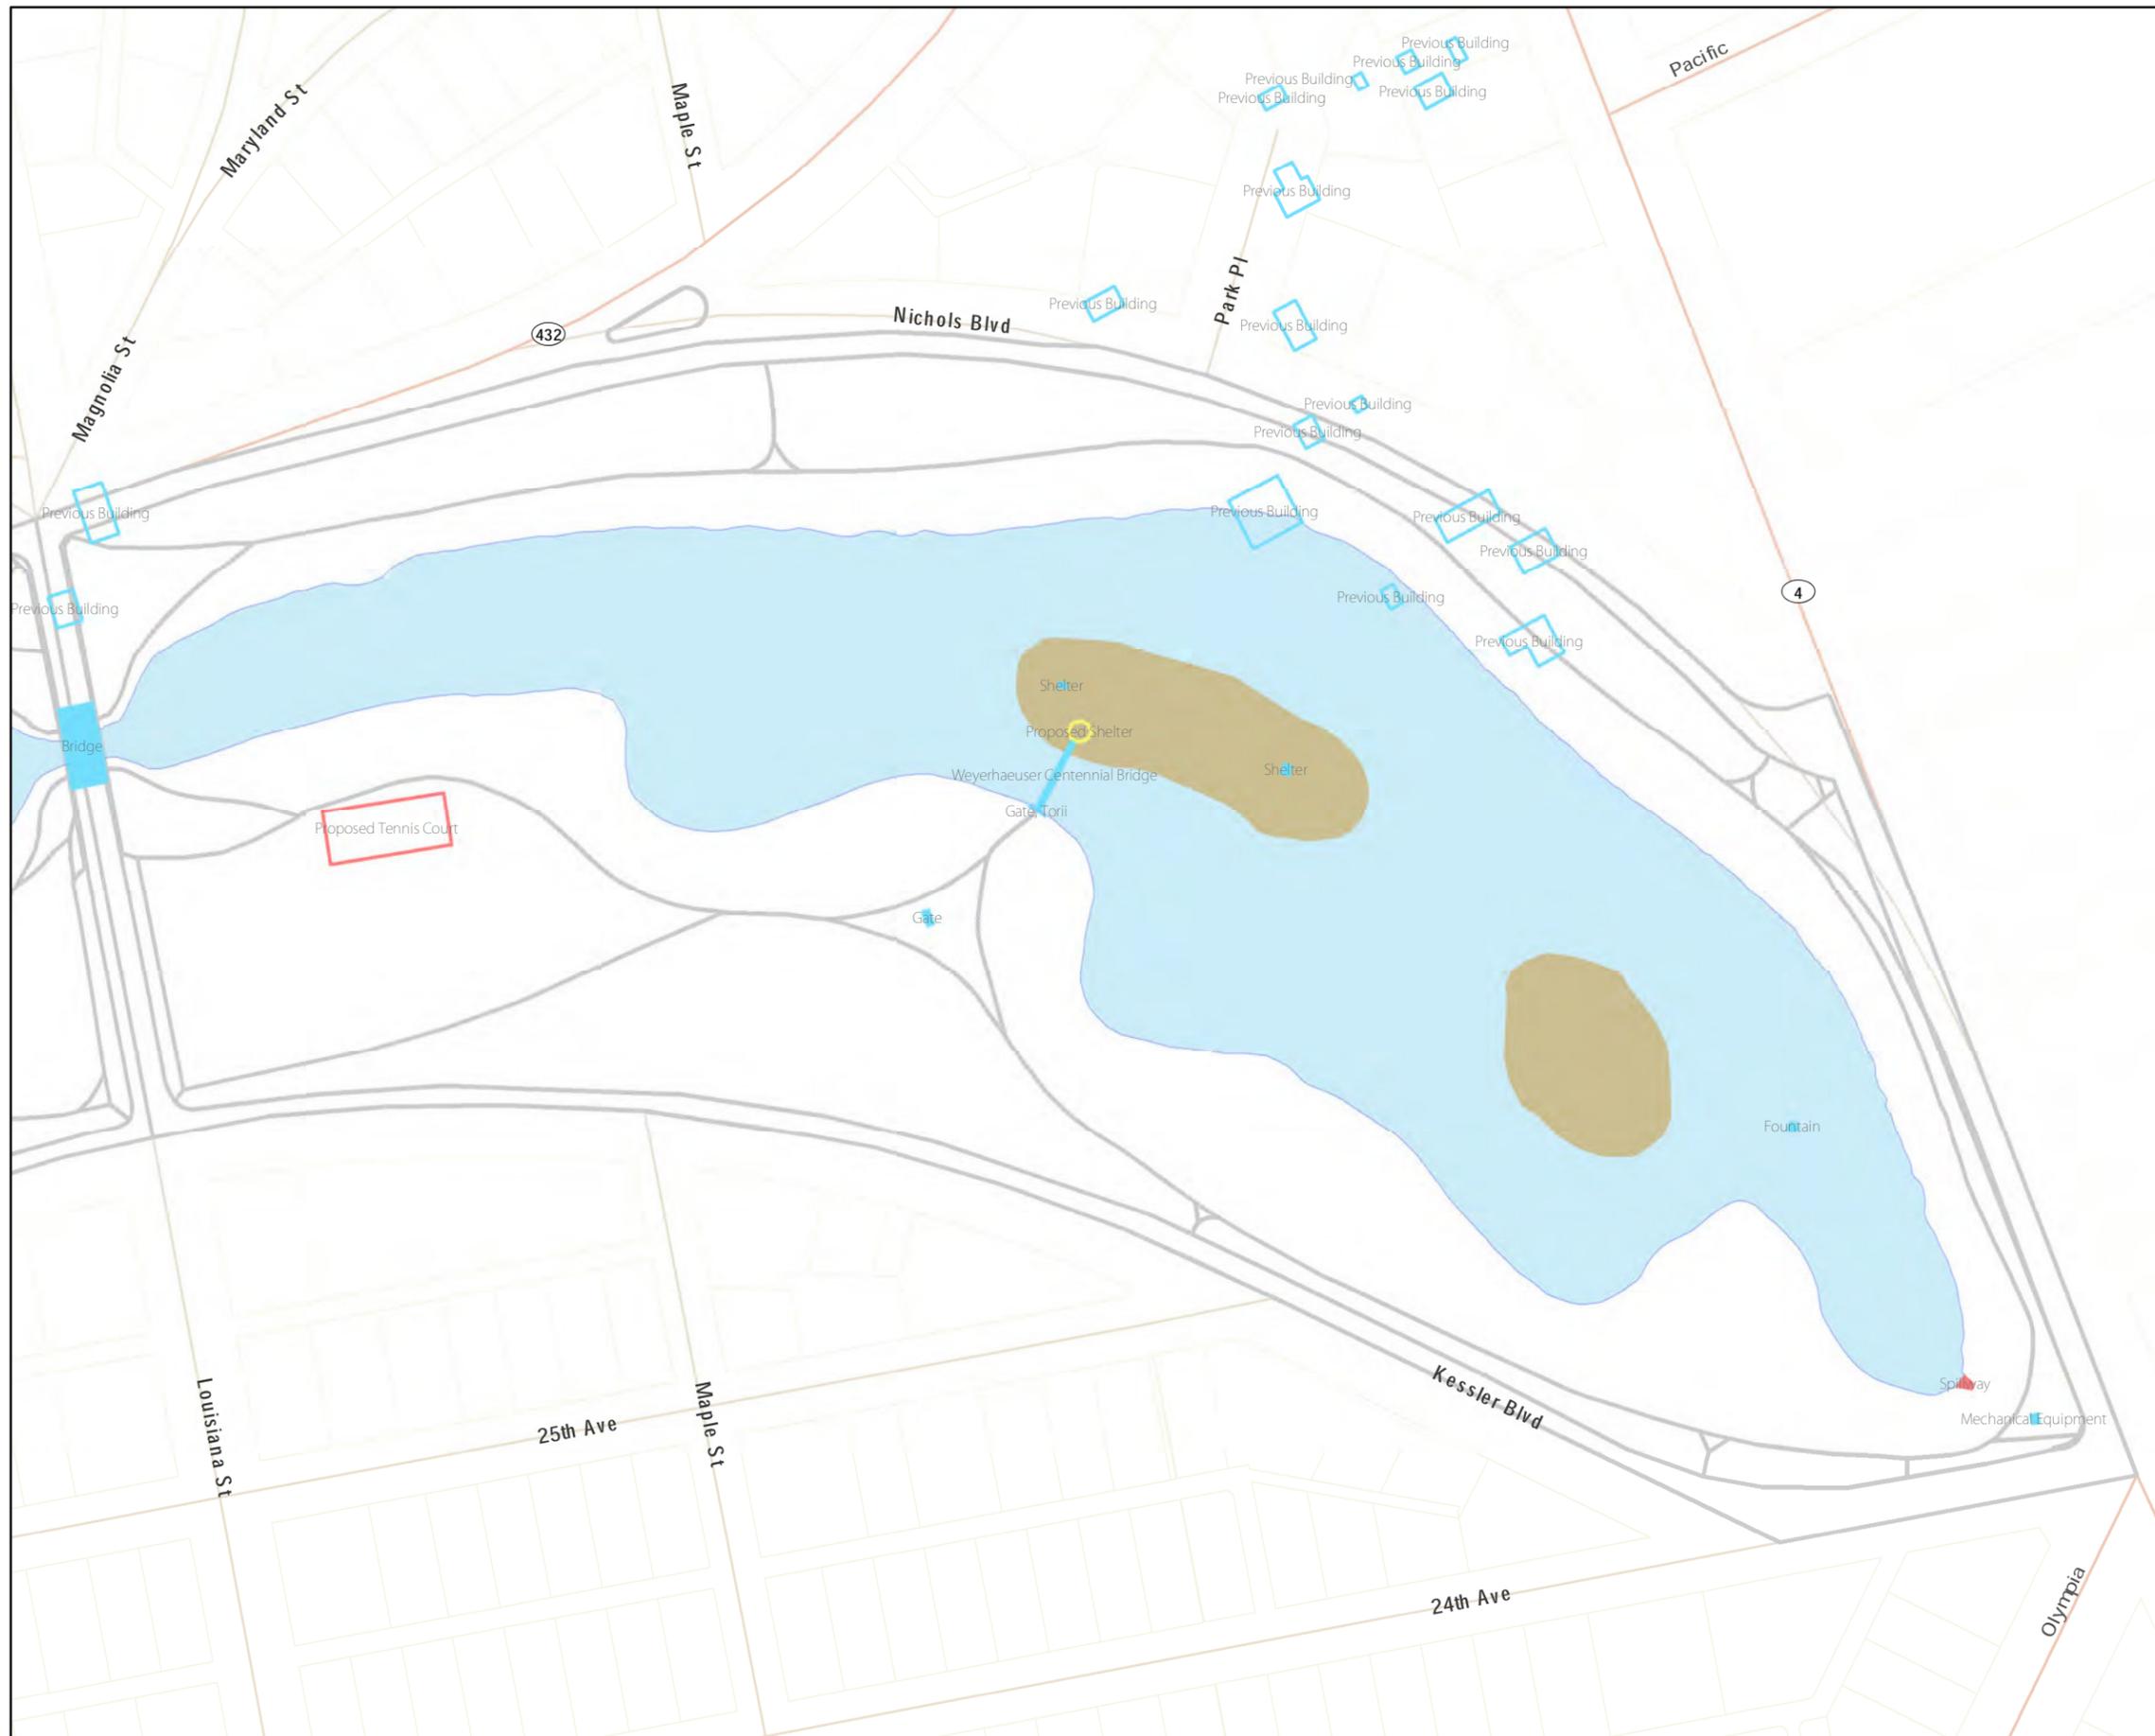
Section B

Built Environment Status, Level, Condition

- Historic Contributing, Primary, Intact
- Historic Contributing, Primary, Missing
- Historic Contributing, Secondary, Intact
- Historic Contributing, Secondary, Missing
- Historic Contributing, Minimal, Intact
- Historic Contributing, Minimal, Missing
- Historic Non-Contributing, None, Missing
- Non-Historic Non-Contributing, None, Intact

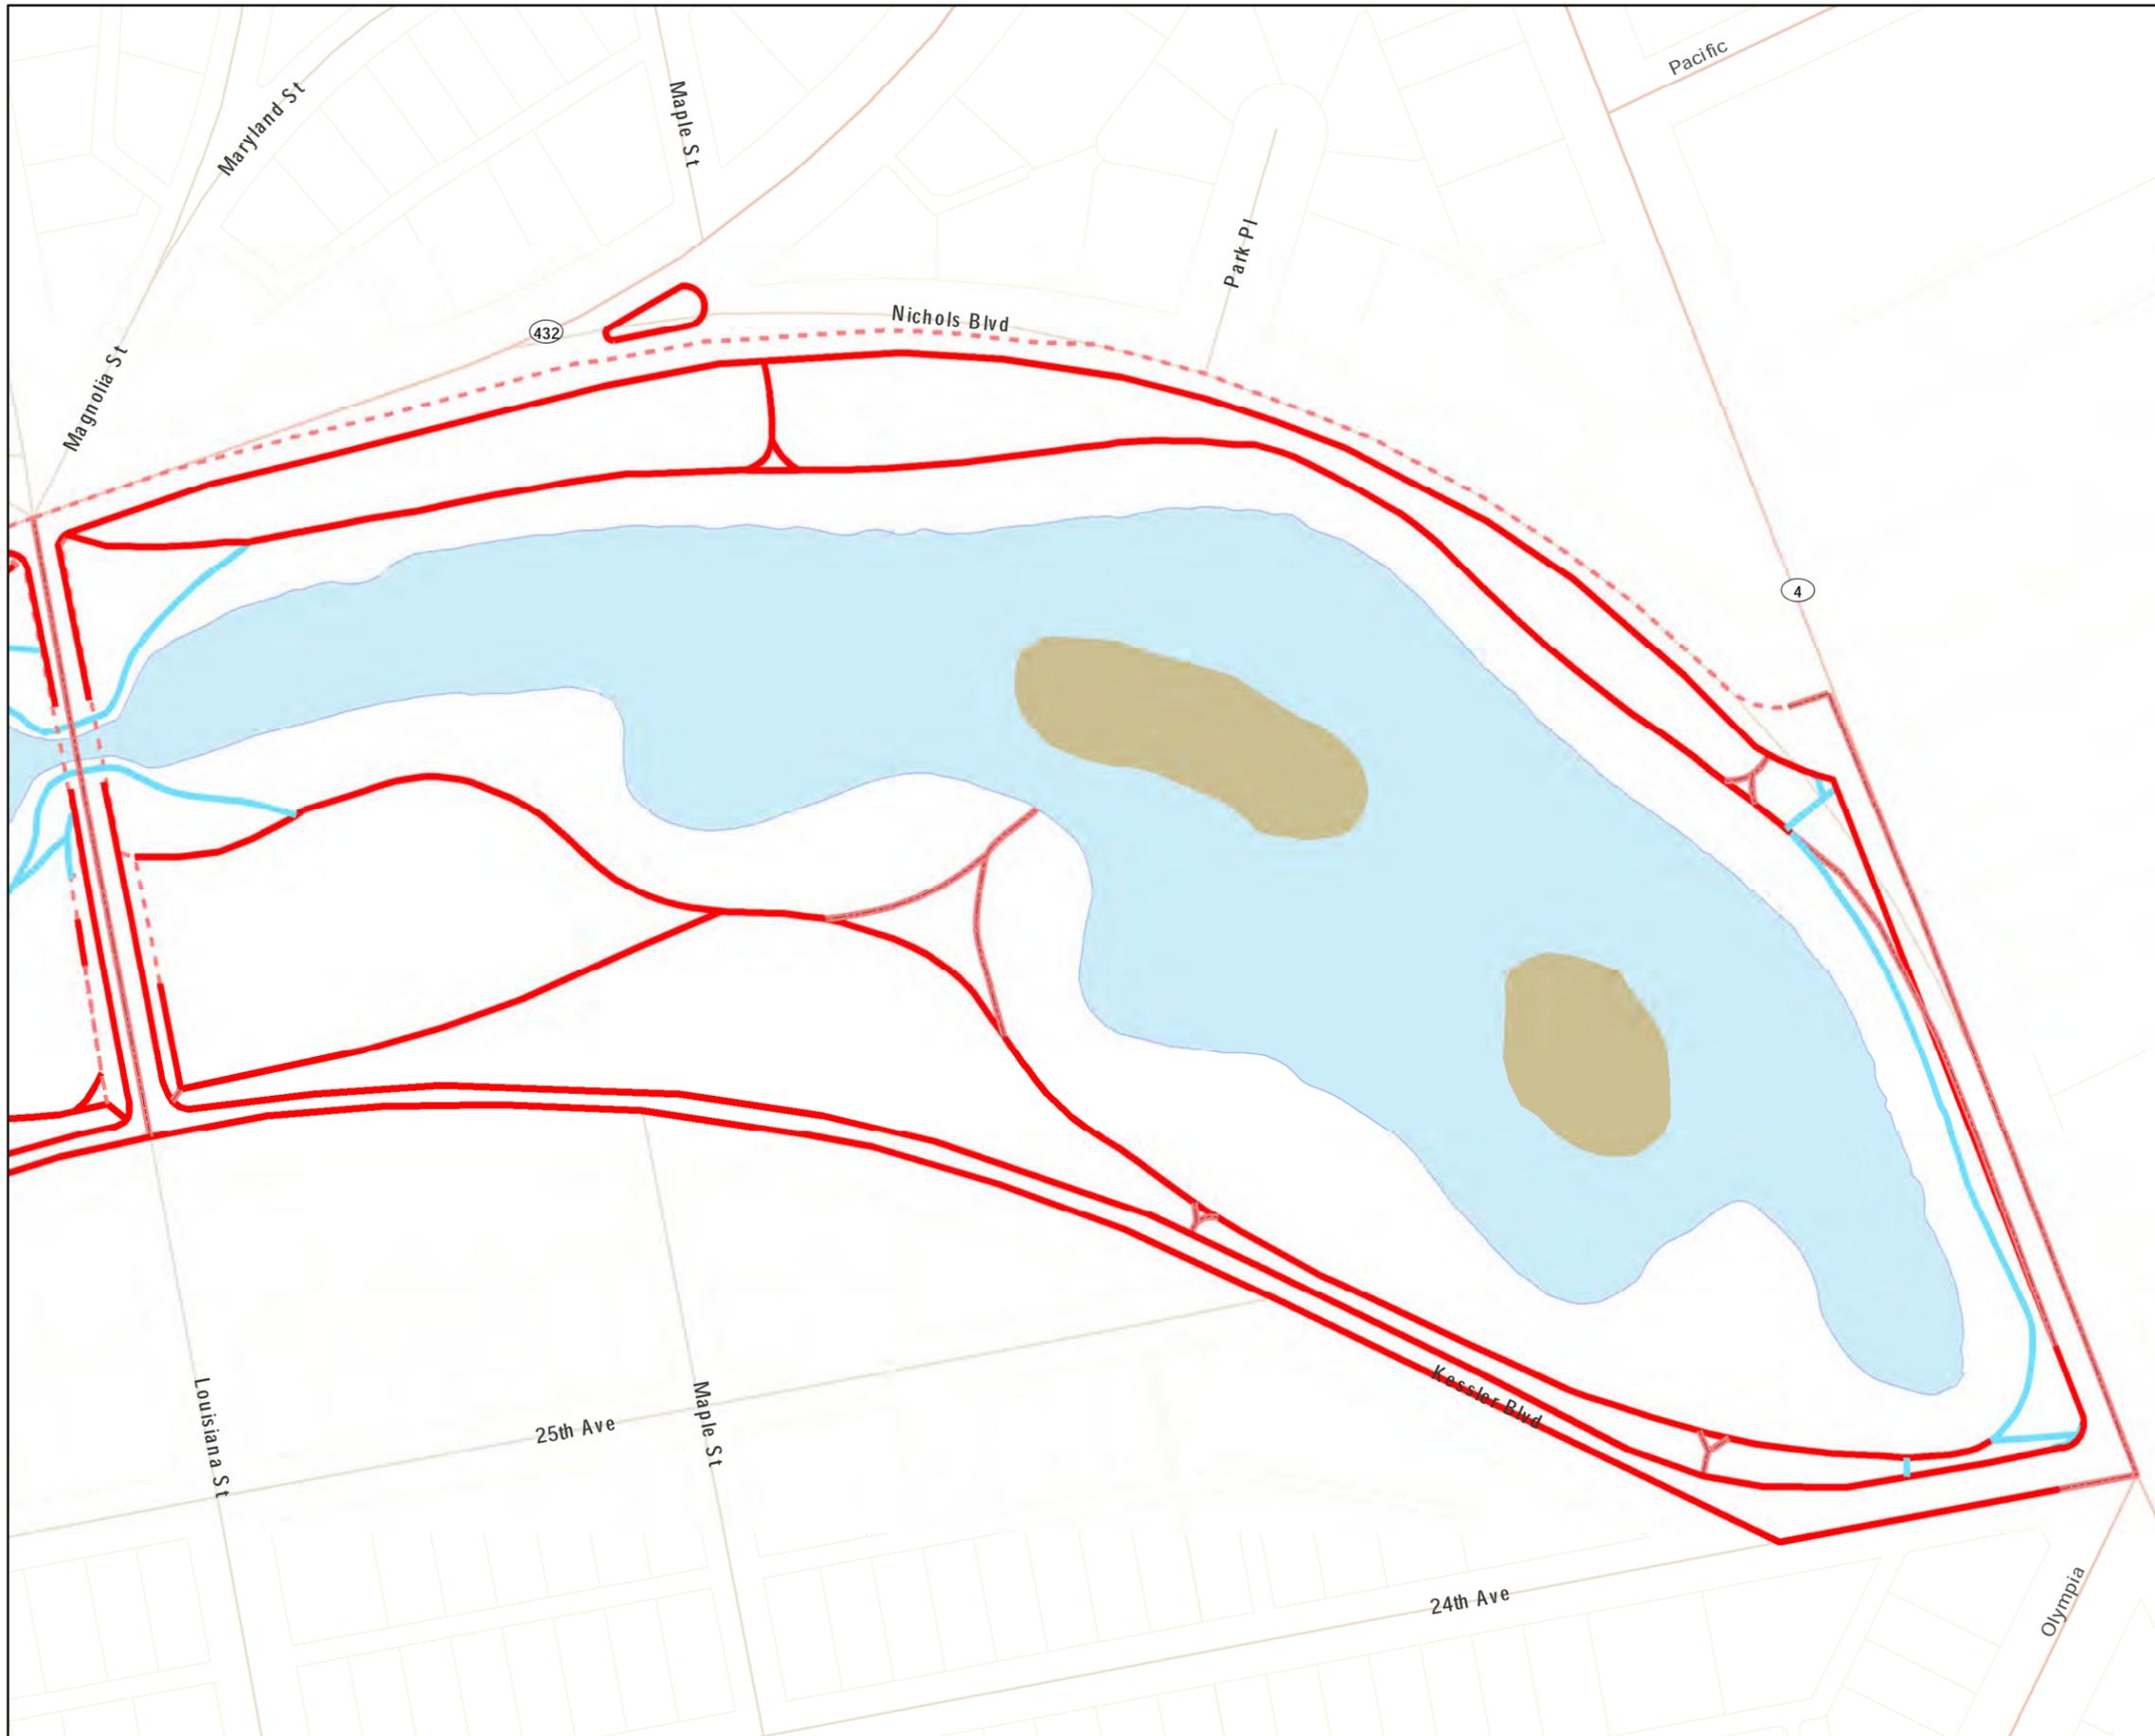
Section B

Status, Level, Condition

- Historic Contributing, Primary, Intact
- - - Historic Contributing, Primary, Damaged
- - - Historic Contributing, Primary, Missing
- - - Historic Contributing, Secondary, Missing
- Non-Historic Non-Contributing, None, Intact

Please note, the circulation networks shown on this map include sidewalks, pathways, curb edges and streets.

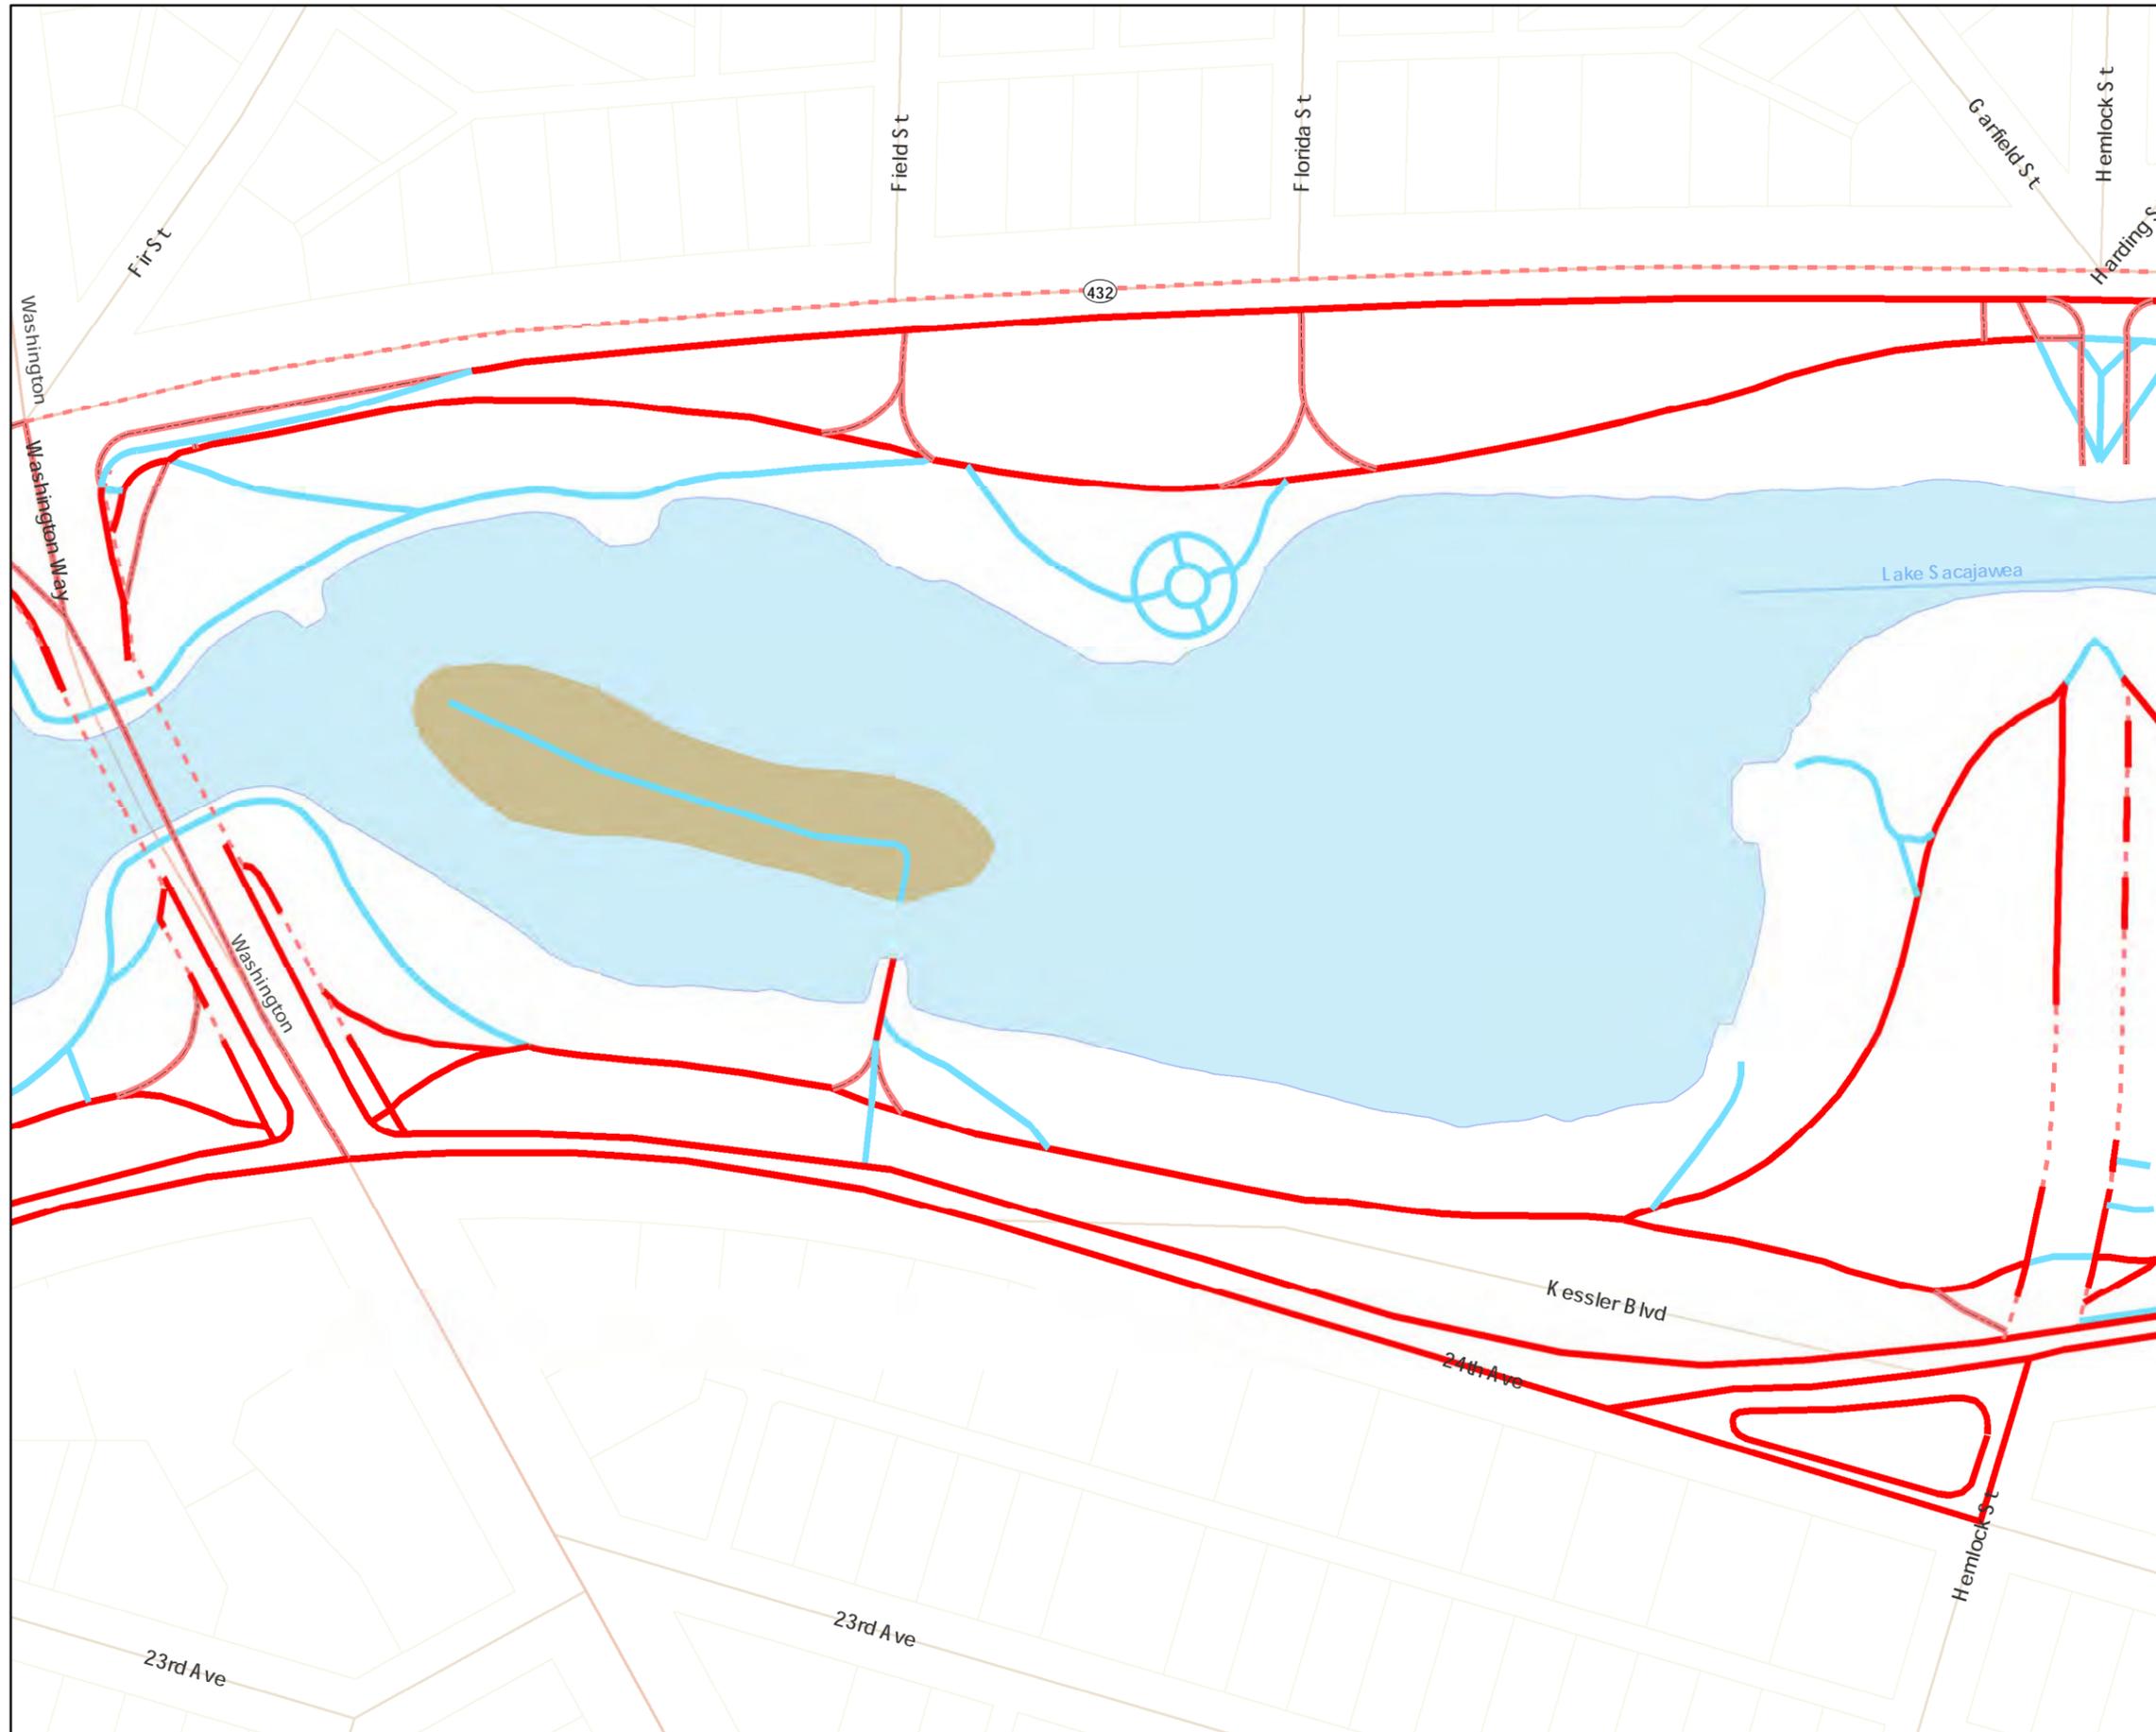
Section D

Circulation Networks
Status, Level, Condition

- Historic Contributing, Primary, Intact
- - - Historic Contributing, Primary, Damaged
- - - Historic Contributing, Primary, Missing
- - - Historic Contributing, Secondary, Missing
- Non-Historic Non-Contributing, None, Intact

Please note, the circulation networks shown on this map include sidewalks, pathways, curb edges and streets.

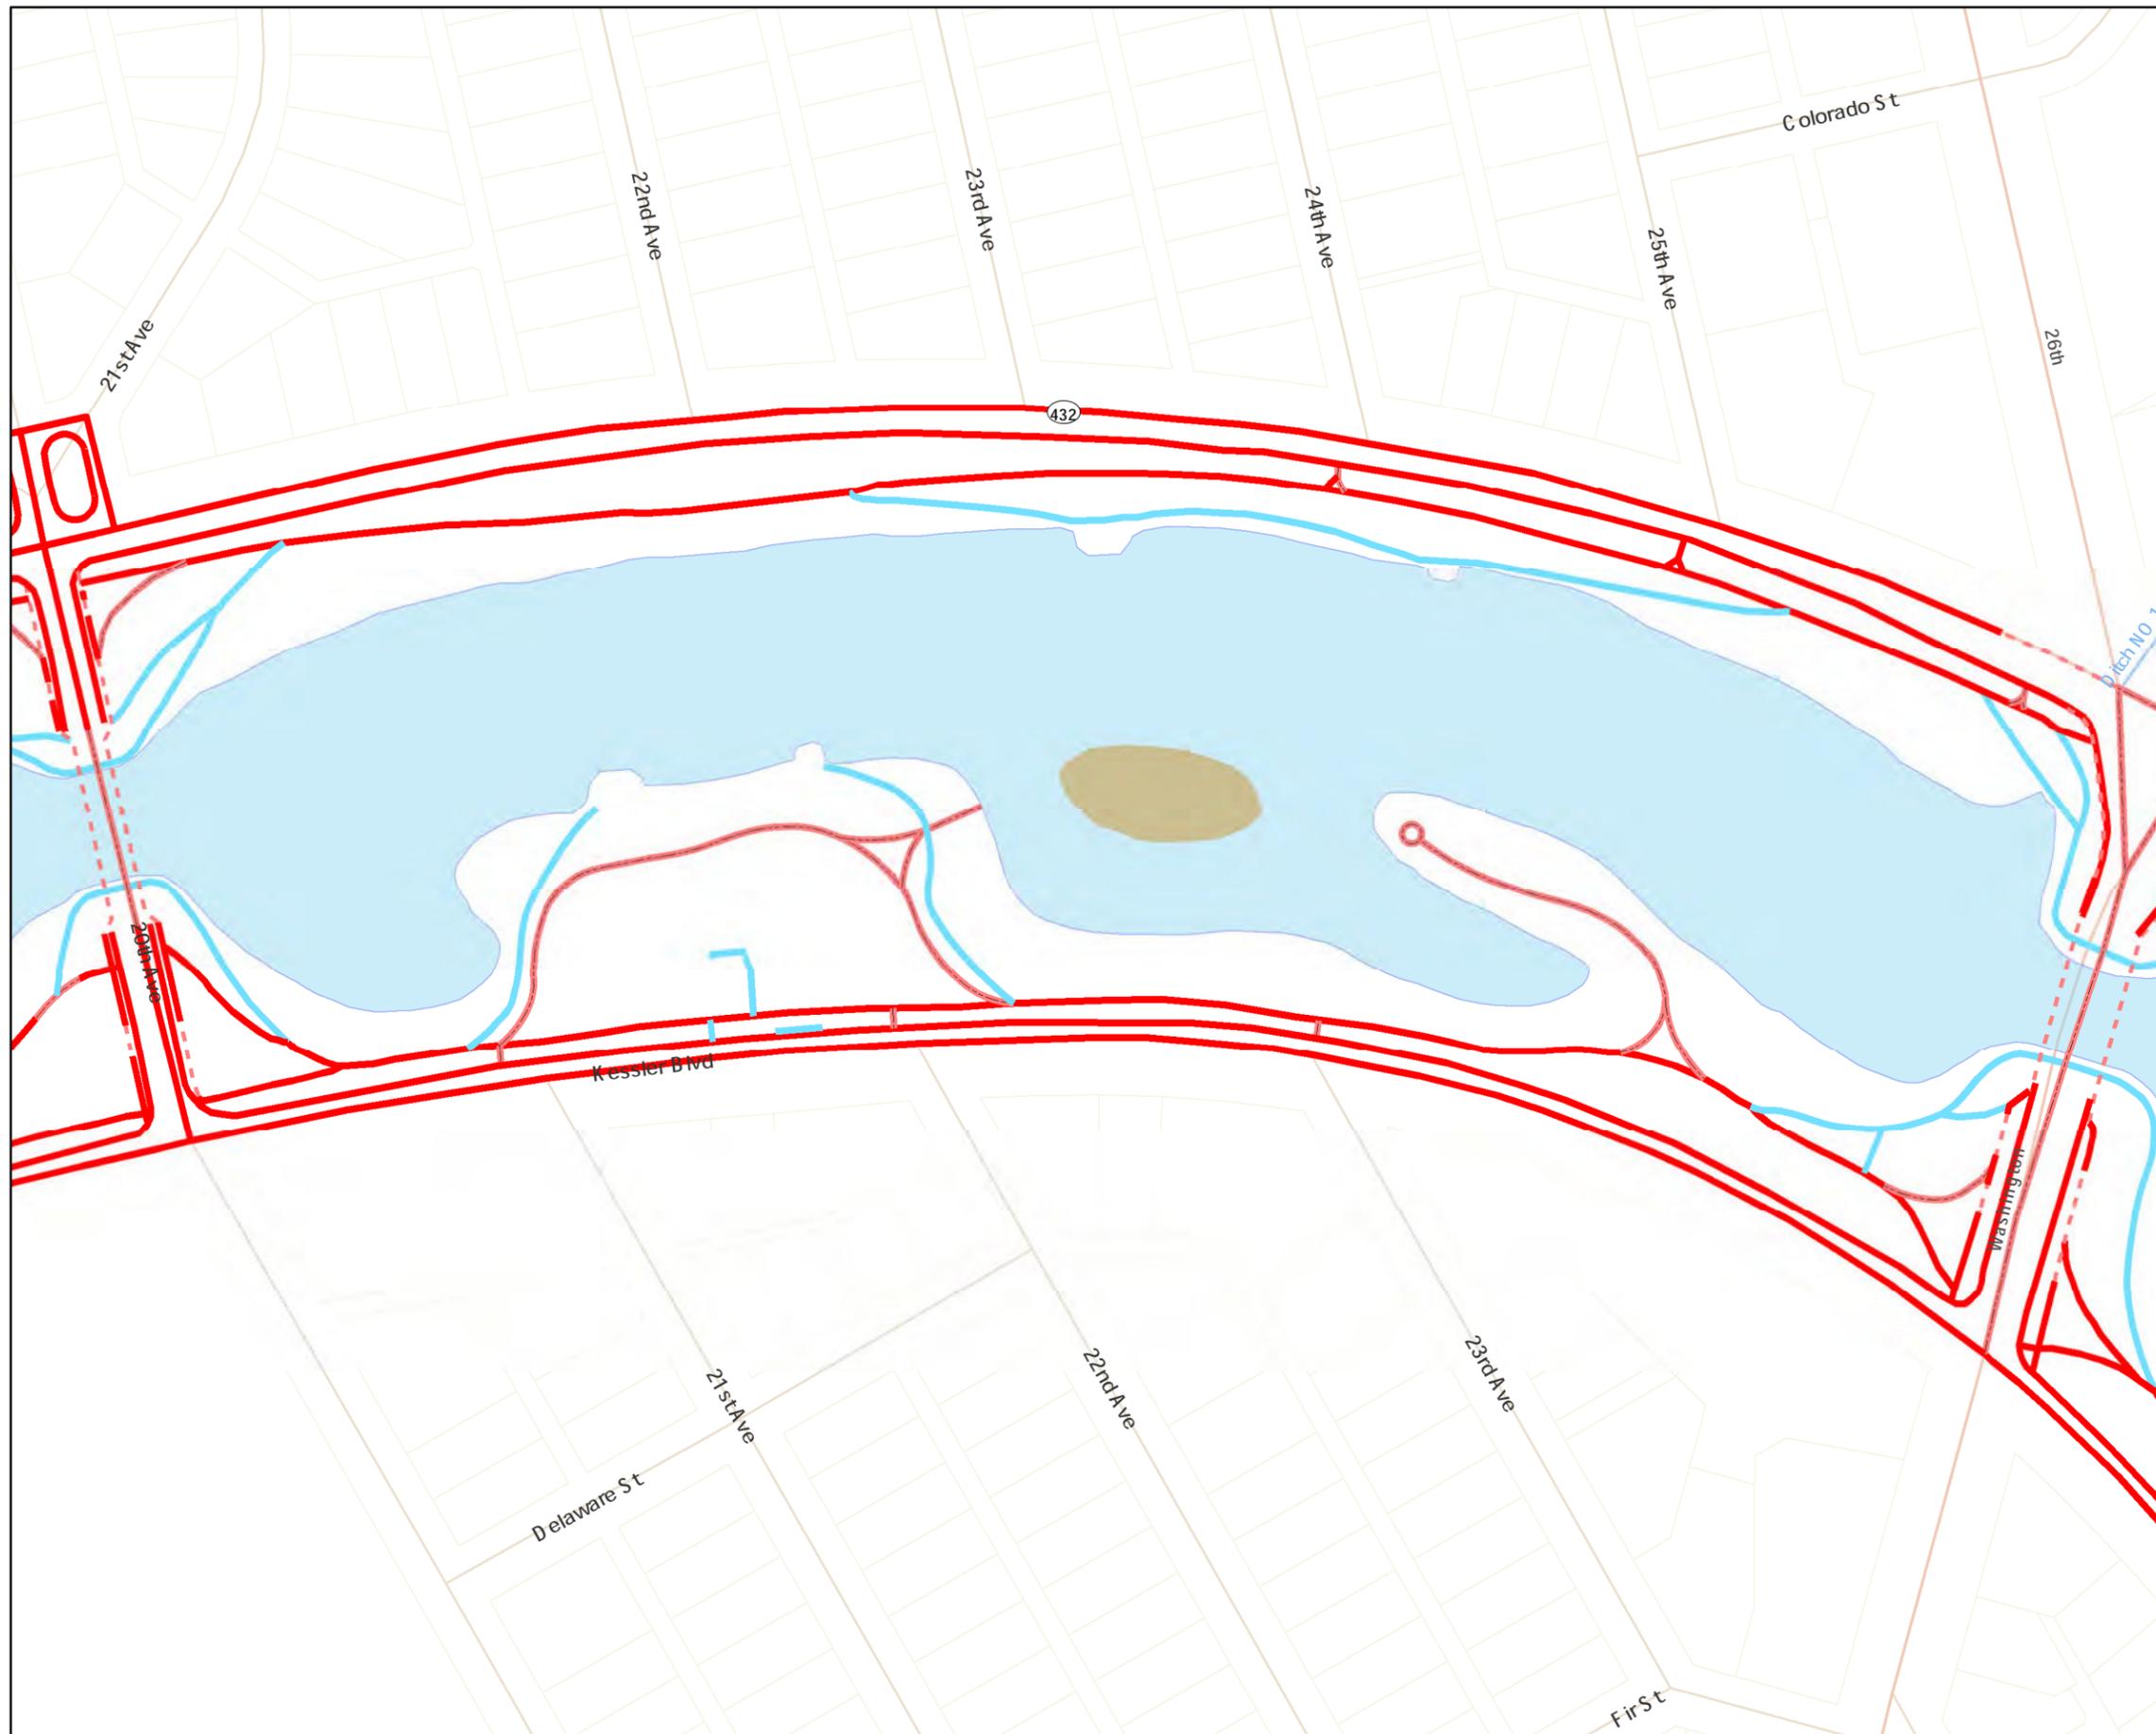
Section E & Sunken Garden

Status, Level, Condition

- Historic Contributing, Primary, Intact
- - - Historic Contributing, Primary, Damaged
- Historic Contributing, Primary, Missing
- - - Historic Contributing, Secondary, Missing
- Non-Historic Non-Contributing, None, Intact

Please note, the circulation networks shown on this map include sidewalks, pathways, curb edges and streets.
