EVALUATION

2.1 CONDITION ASSESSMENT

City of Longview Lake Sacajawea Park Preservation Plan

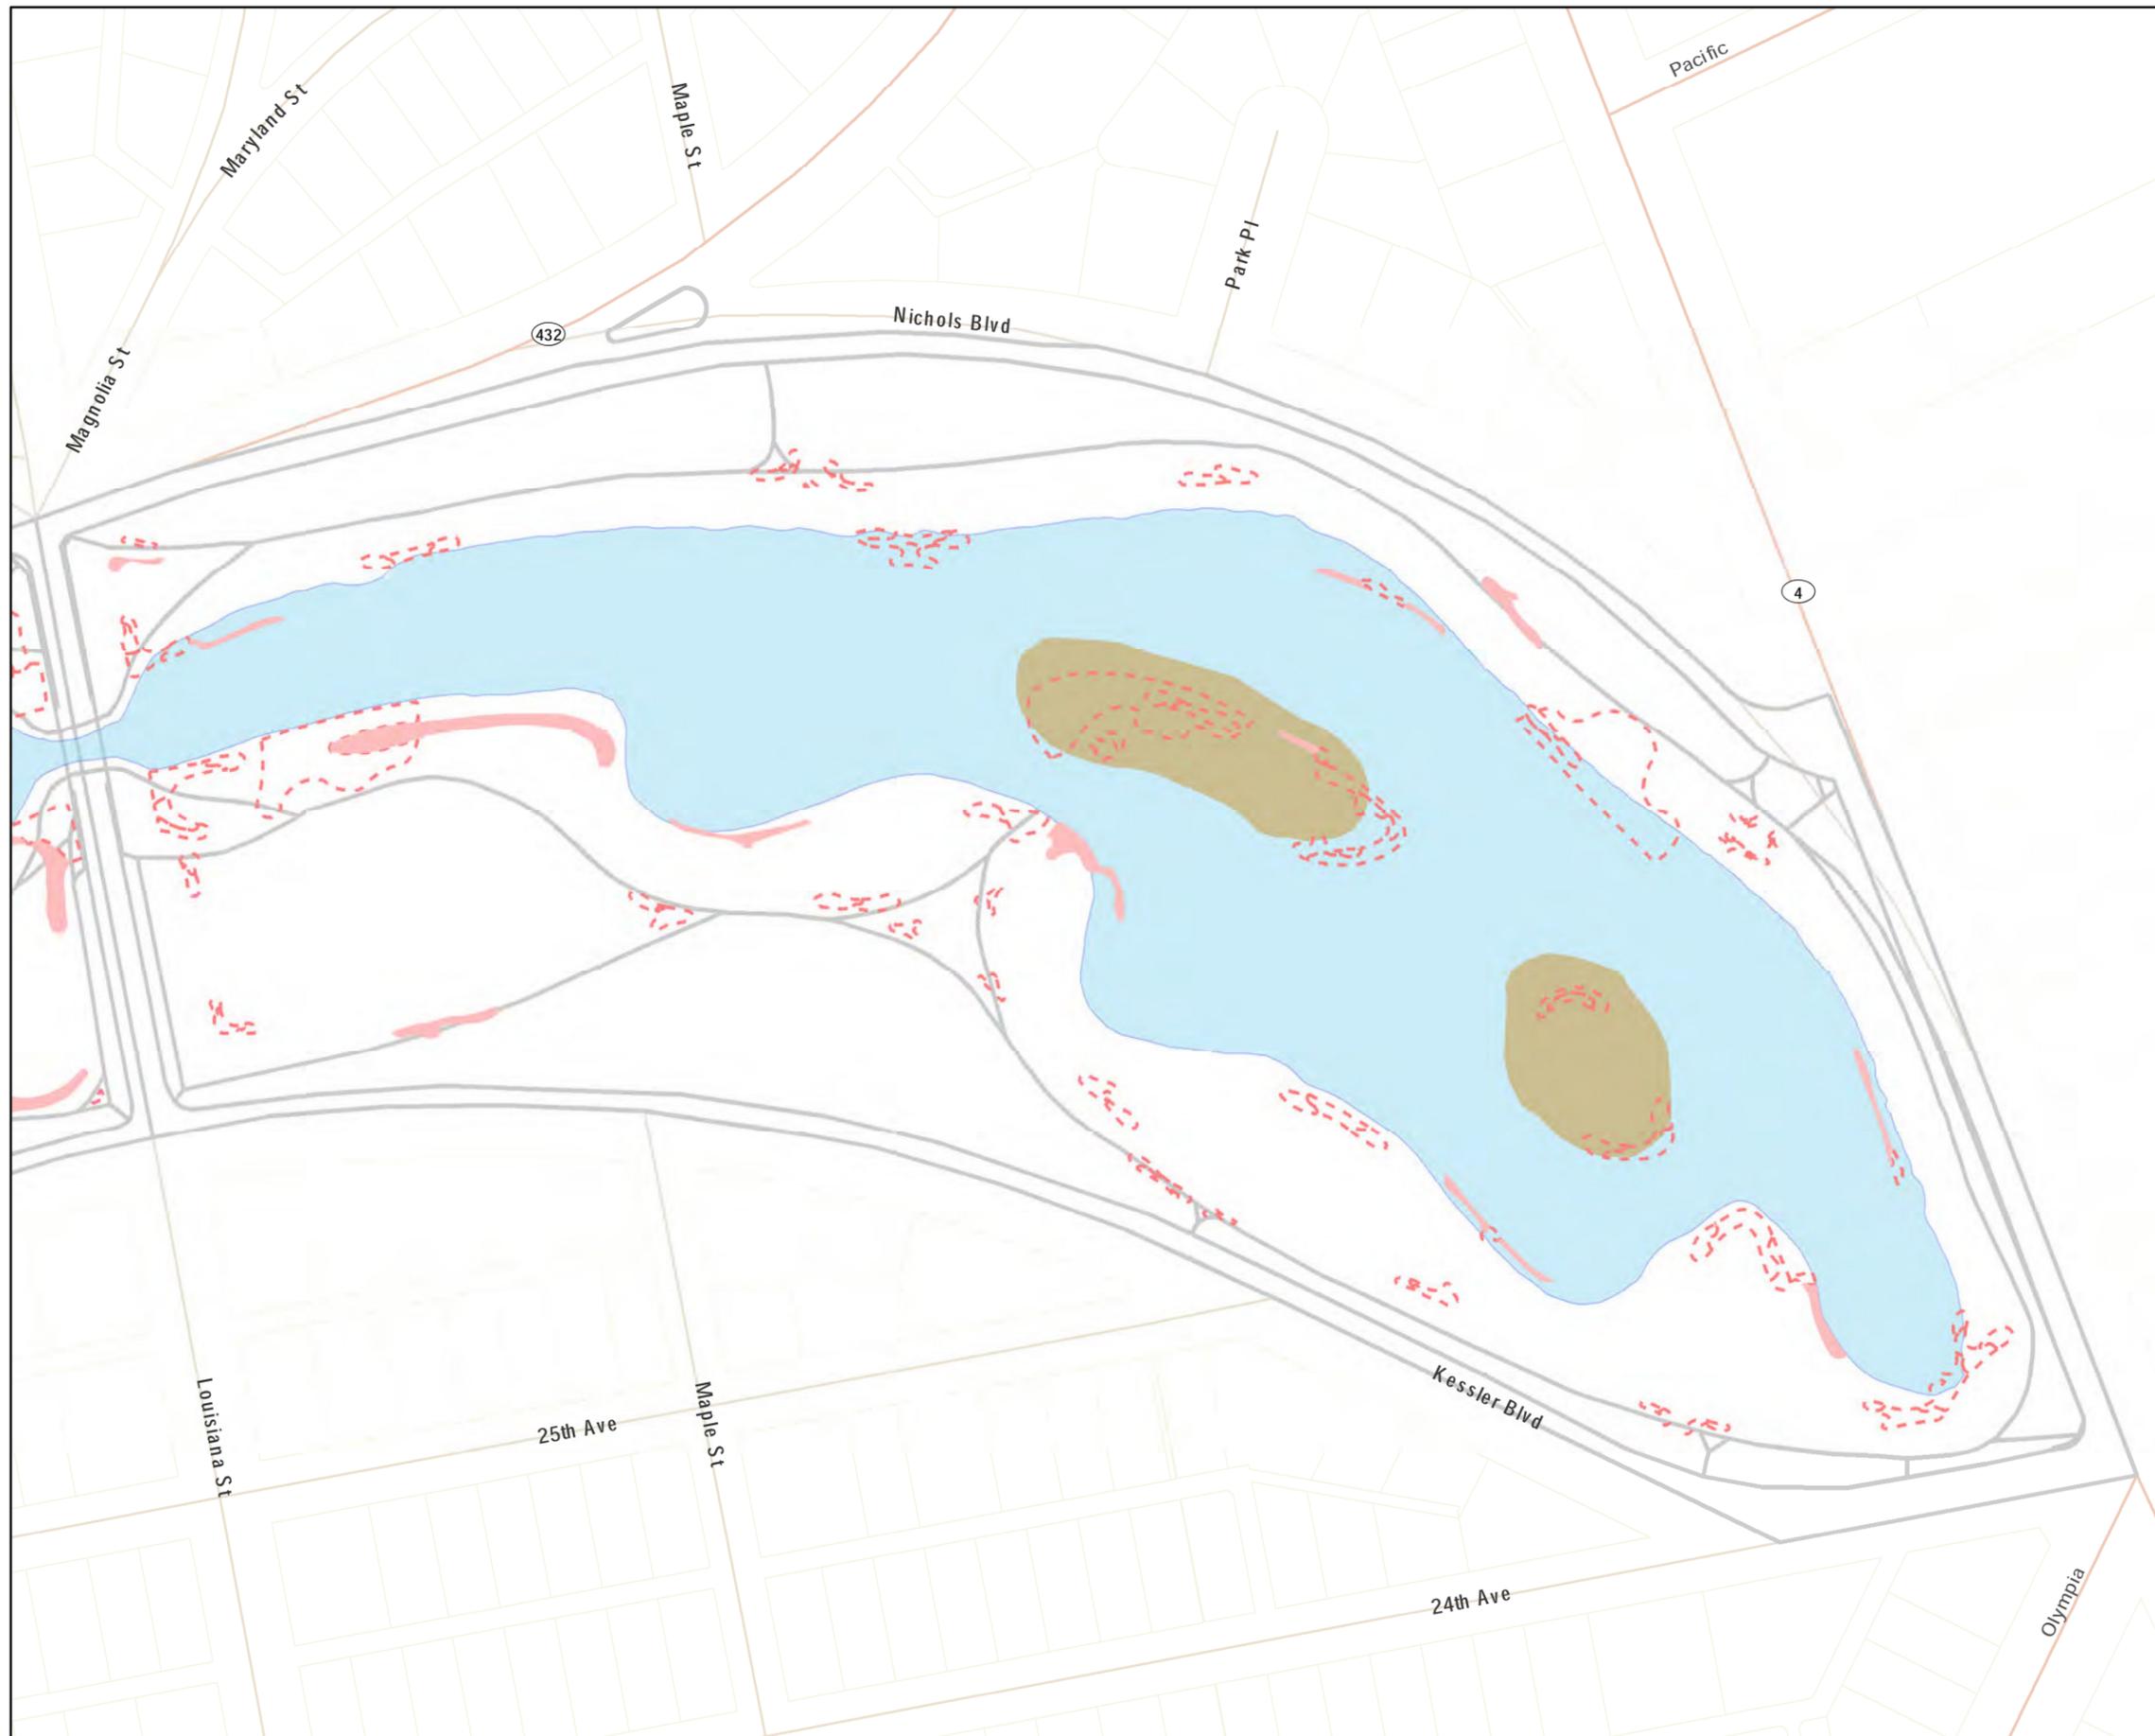
Section B

Status, Level, Condition

Historic Contributing, Primary, Damaged
-

Historic Contributing, Primary, Missing

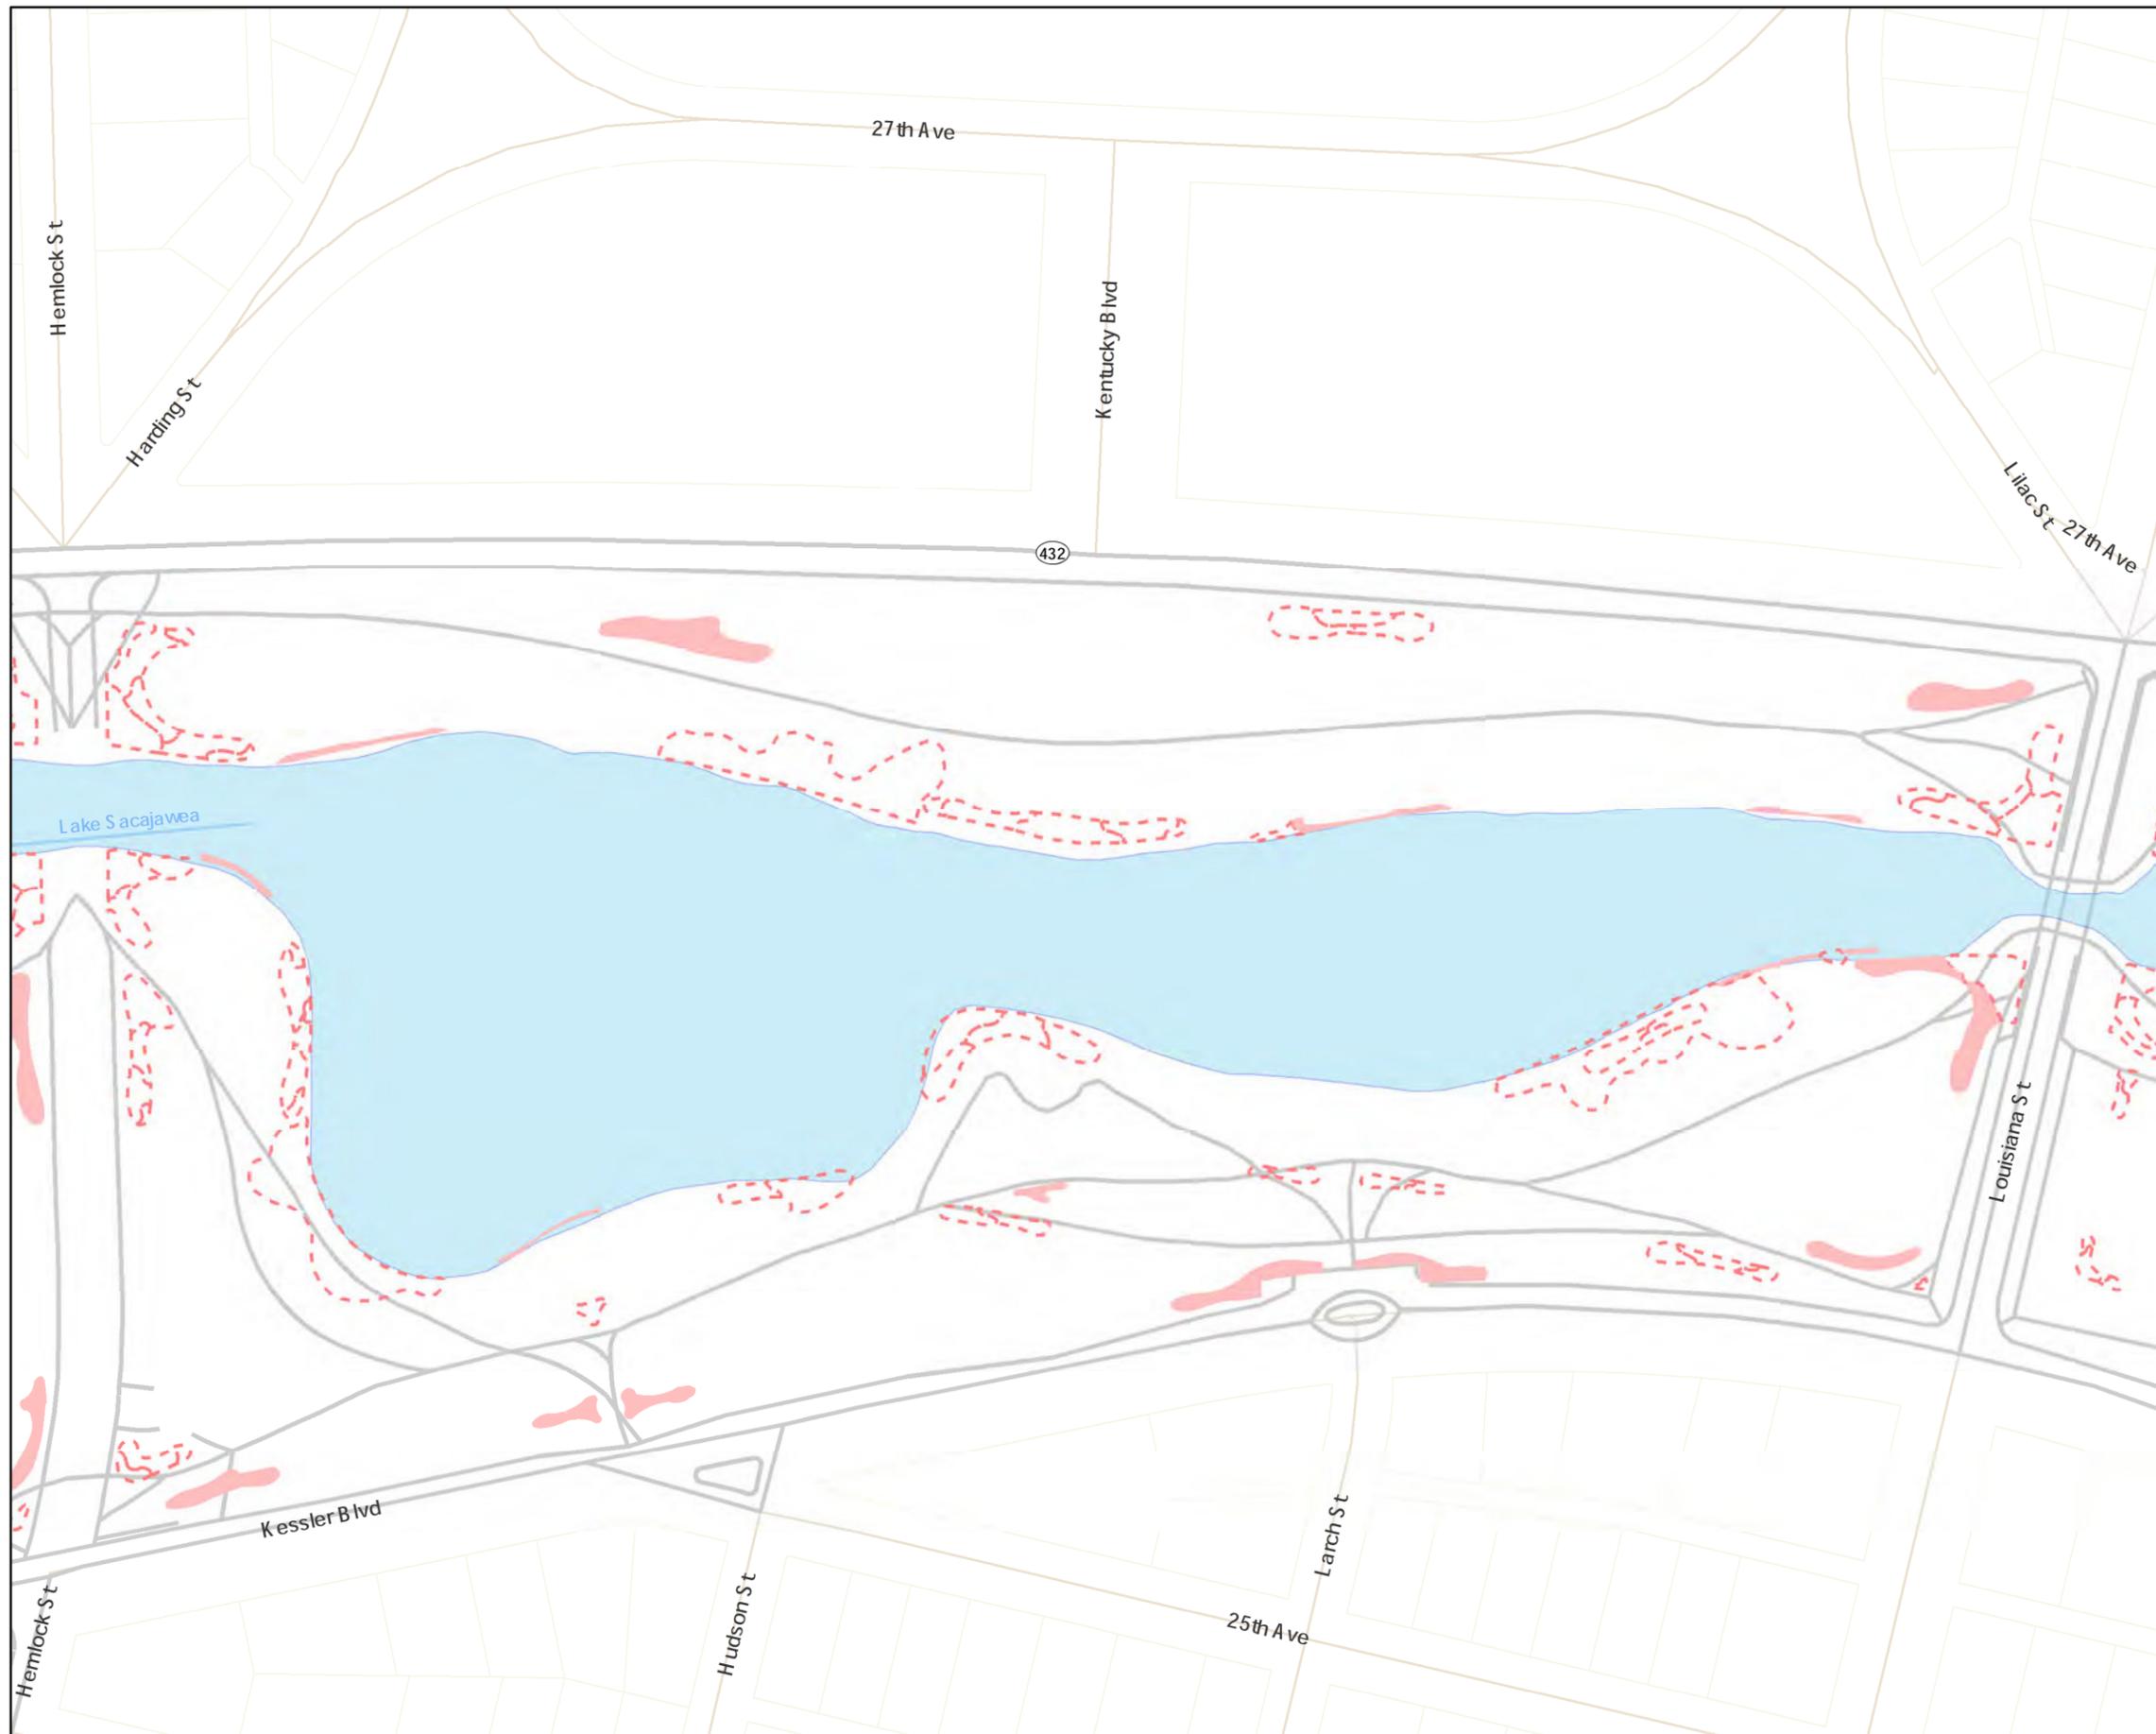
Section C

Status, Level, Condition

Historic Contributing, Primary, Damaged
-

Historic Contributing, Primary, Missing

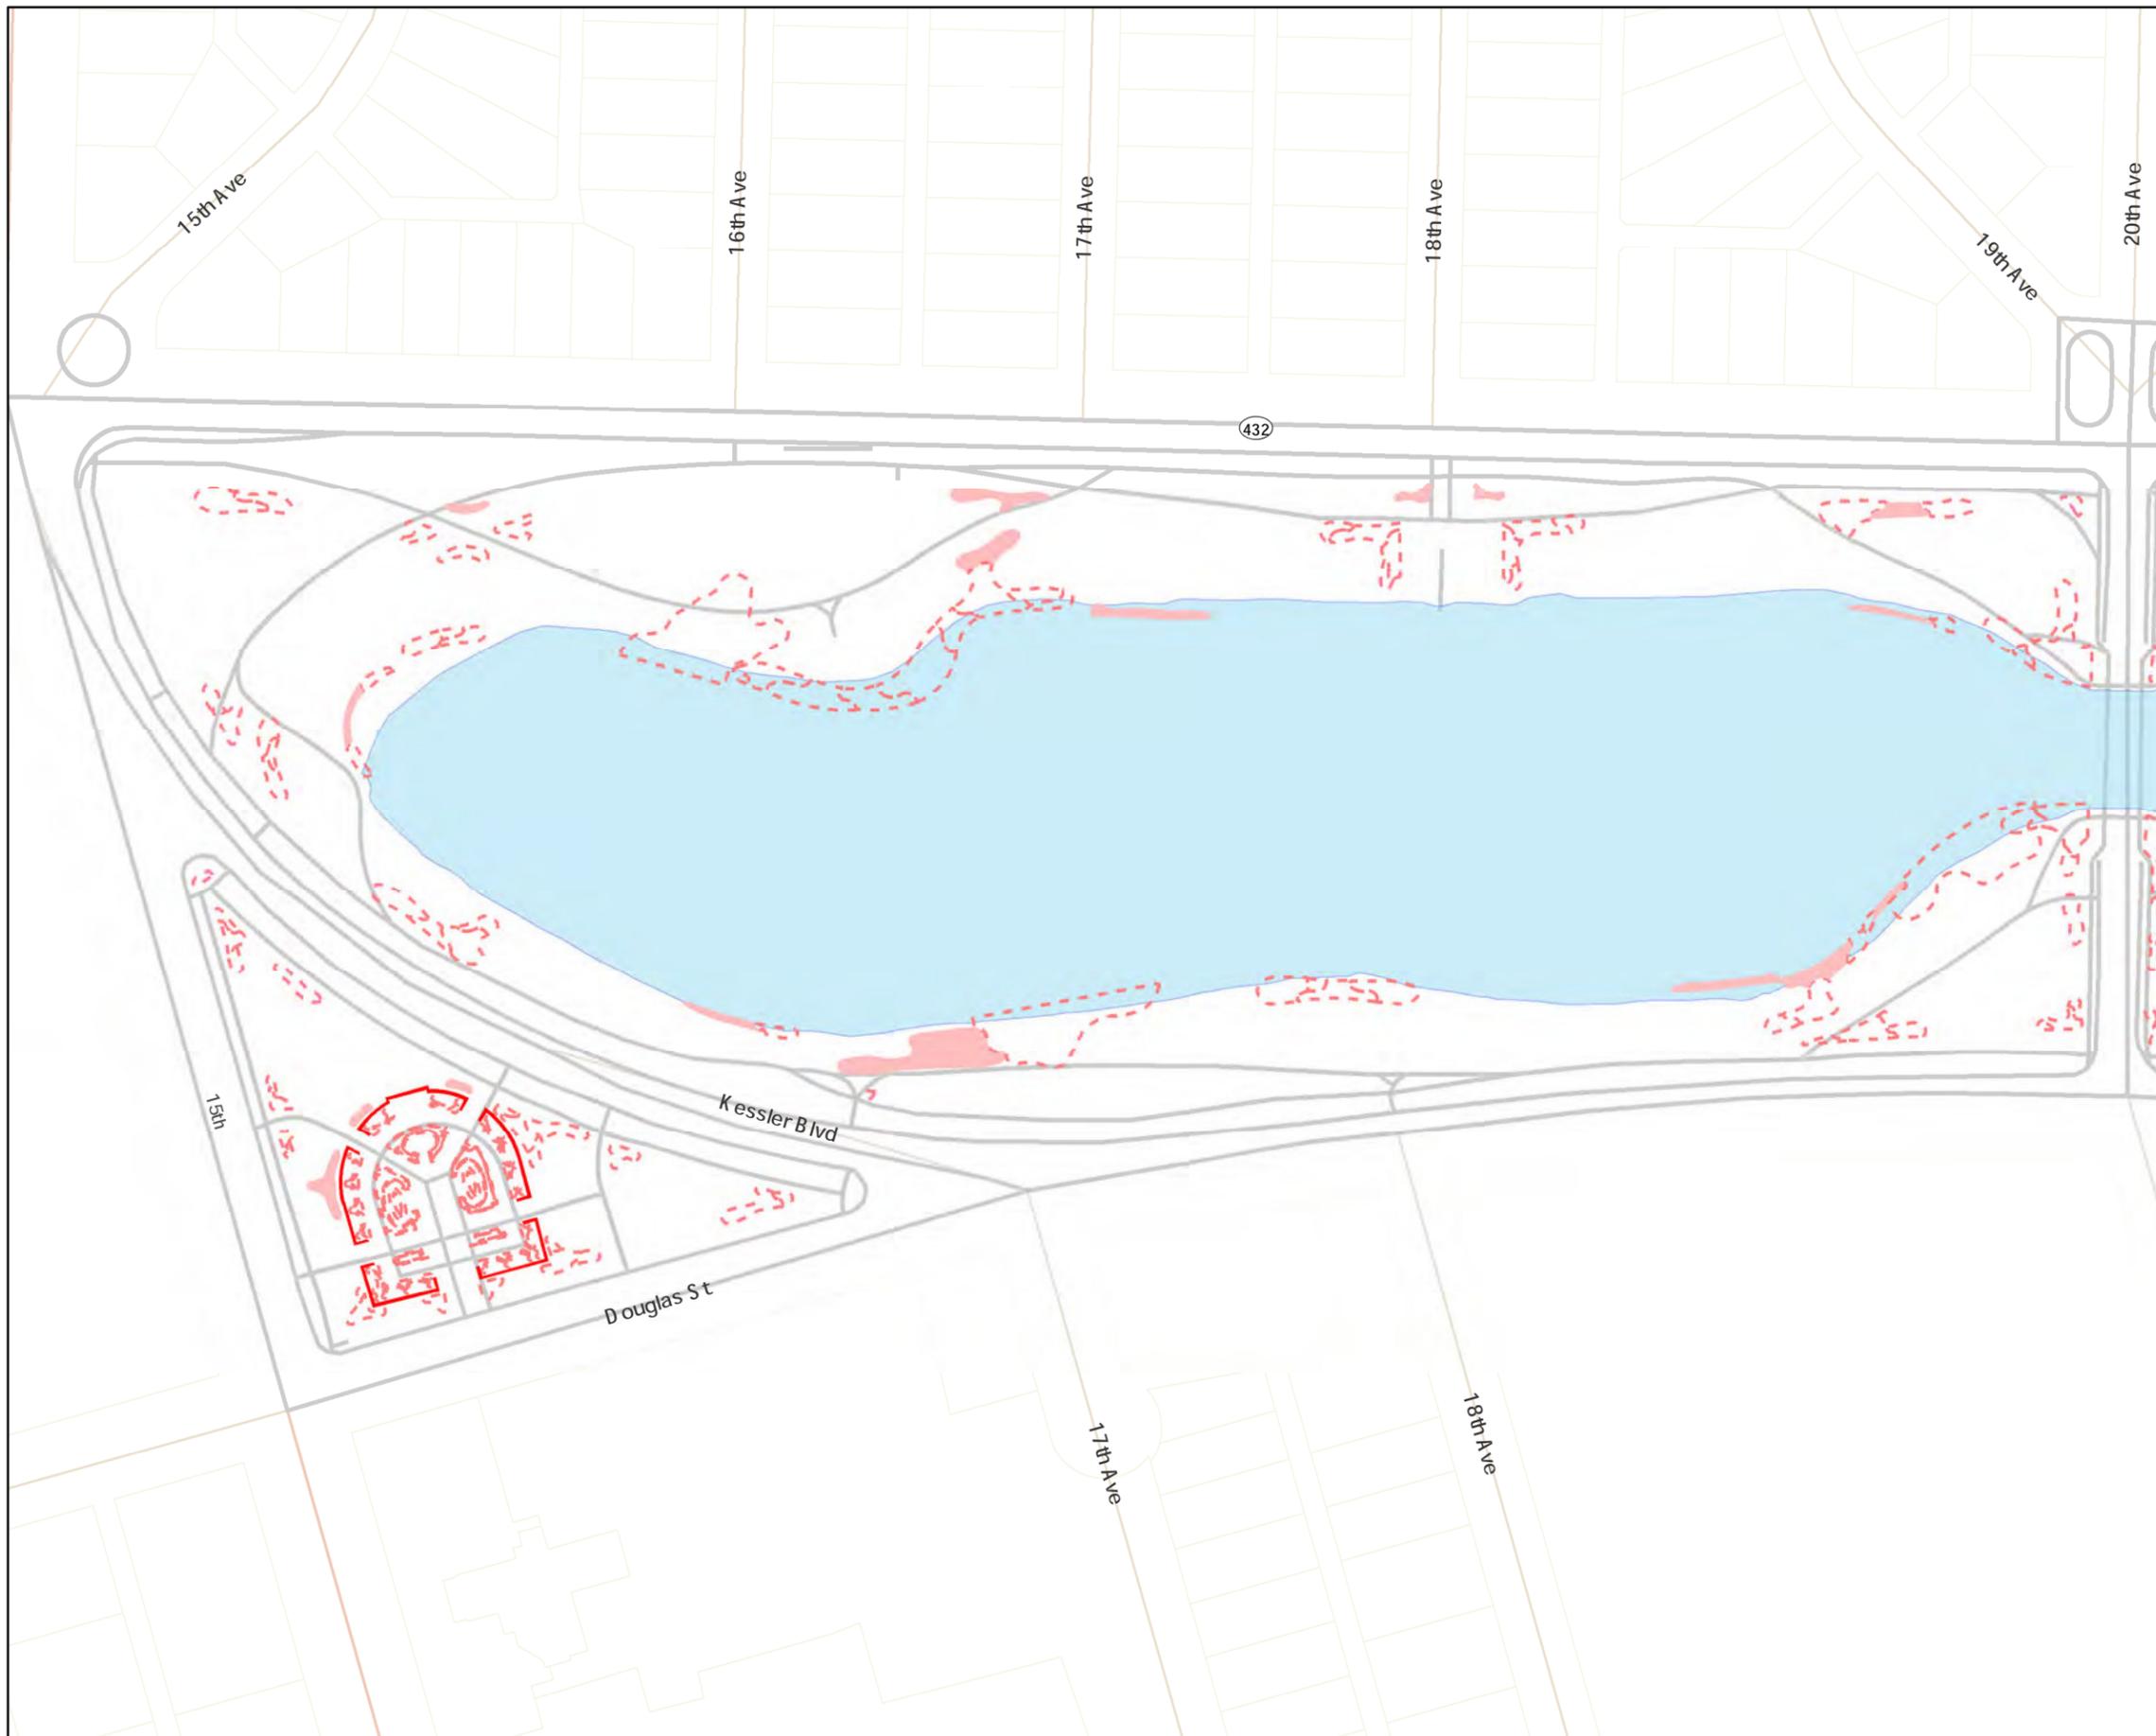
Section A

Status, Level, Condition

Historic Contributing, Primary, Damaged
-

Historic Contributing, Primary, Missing

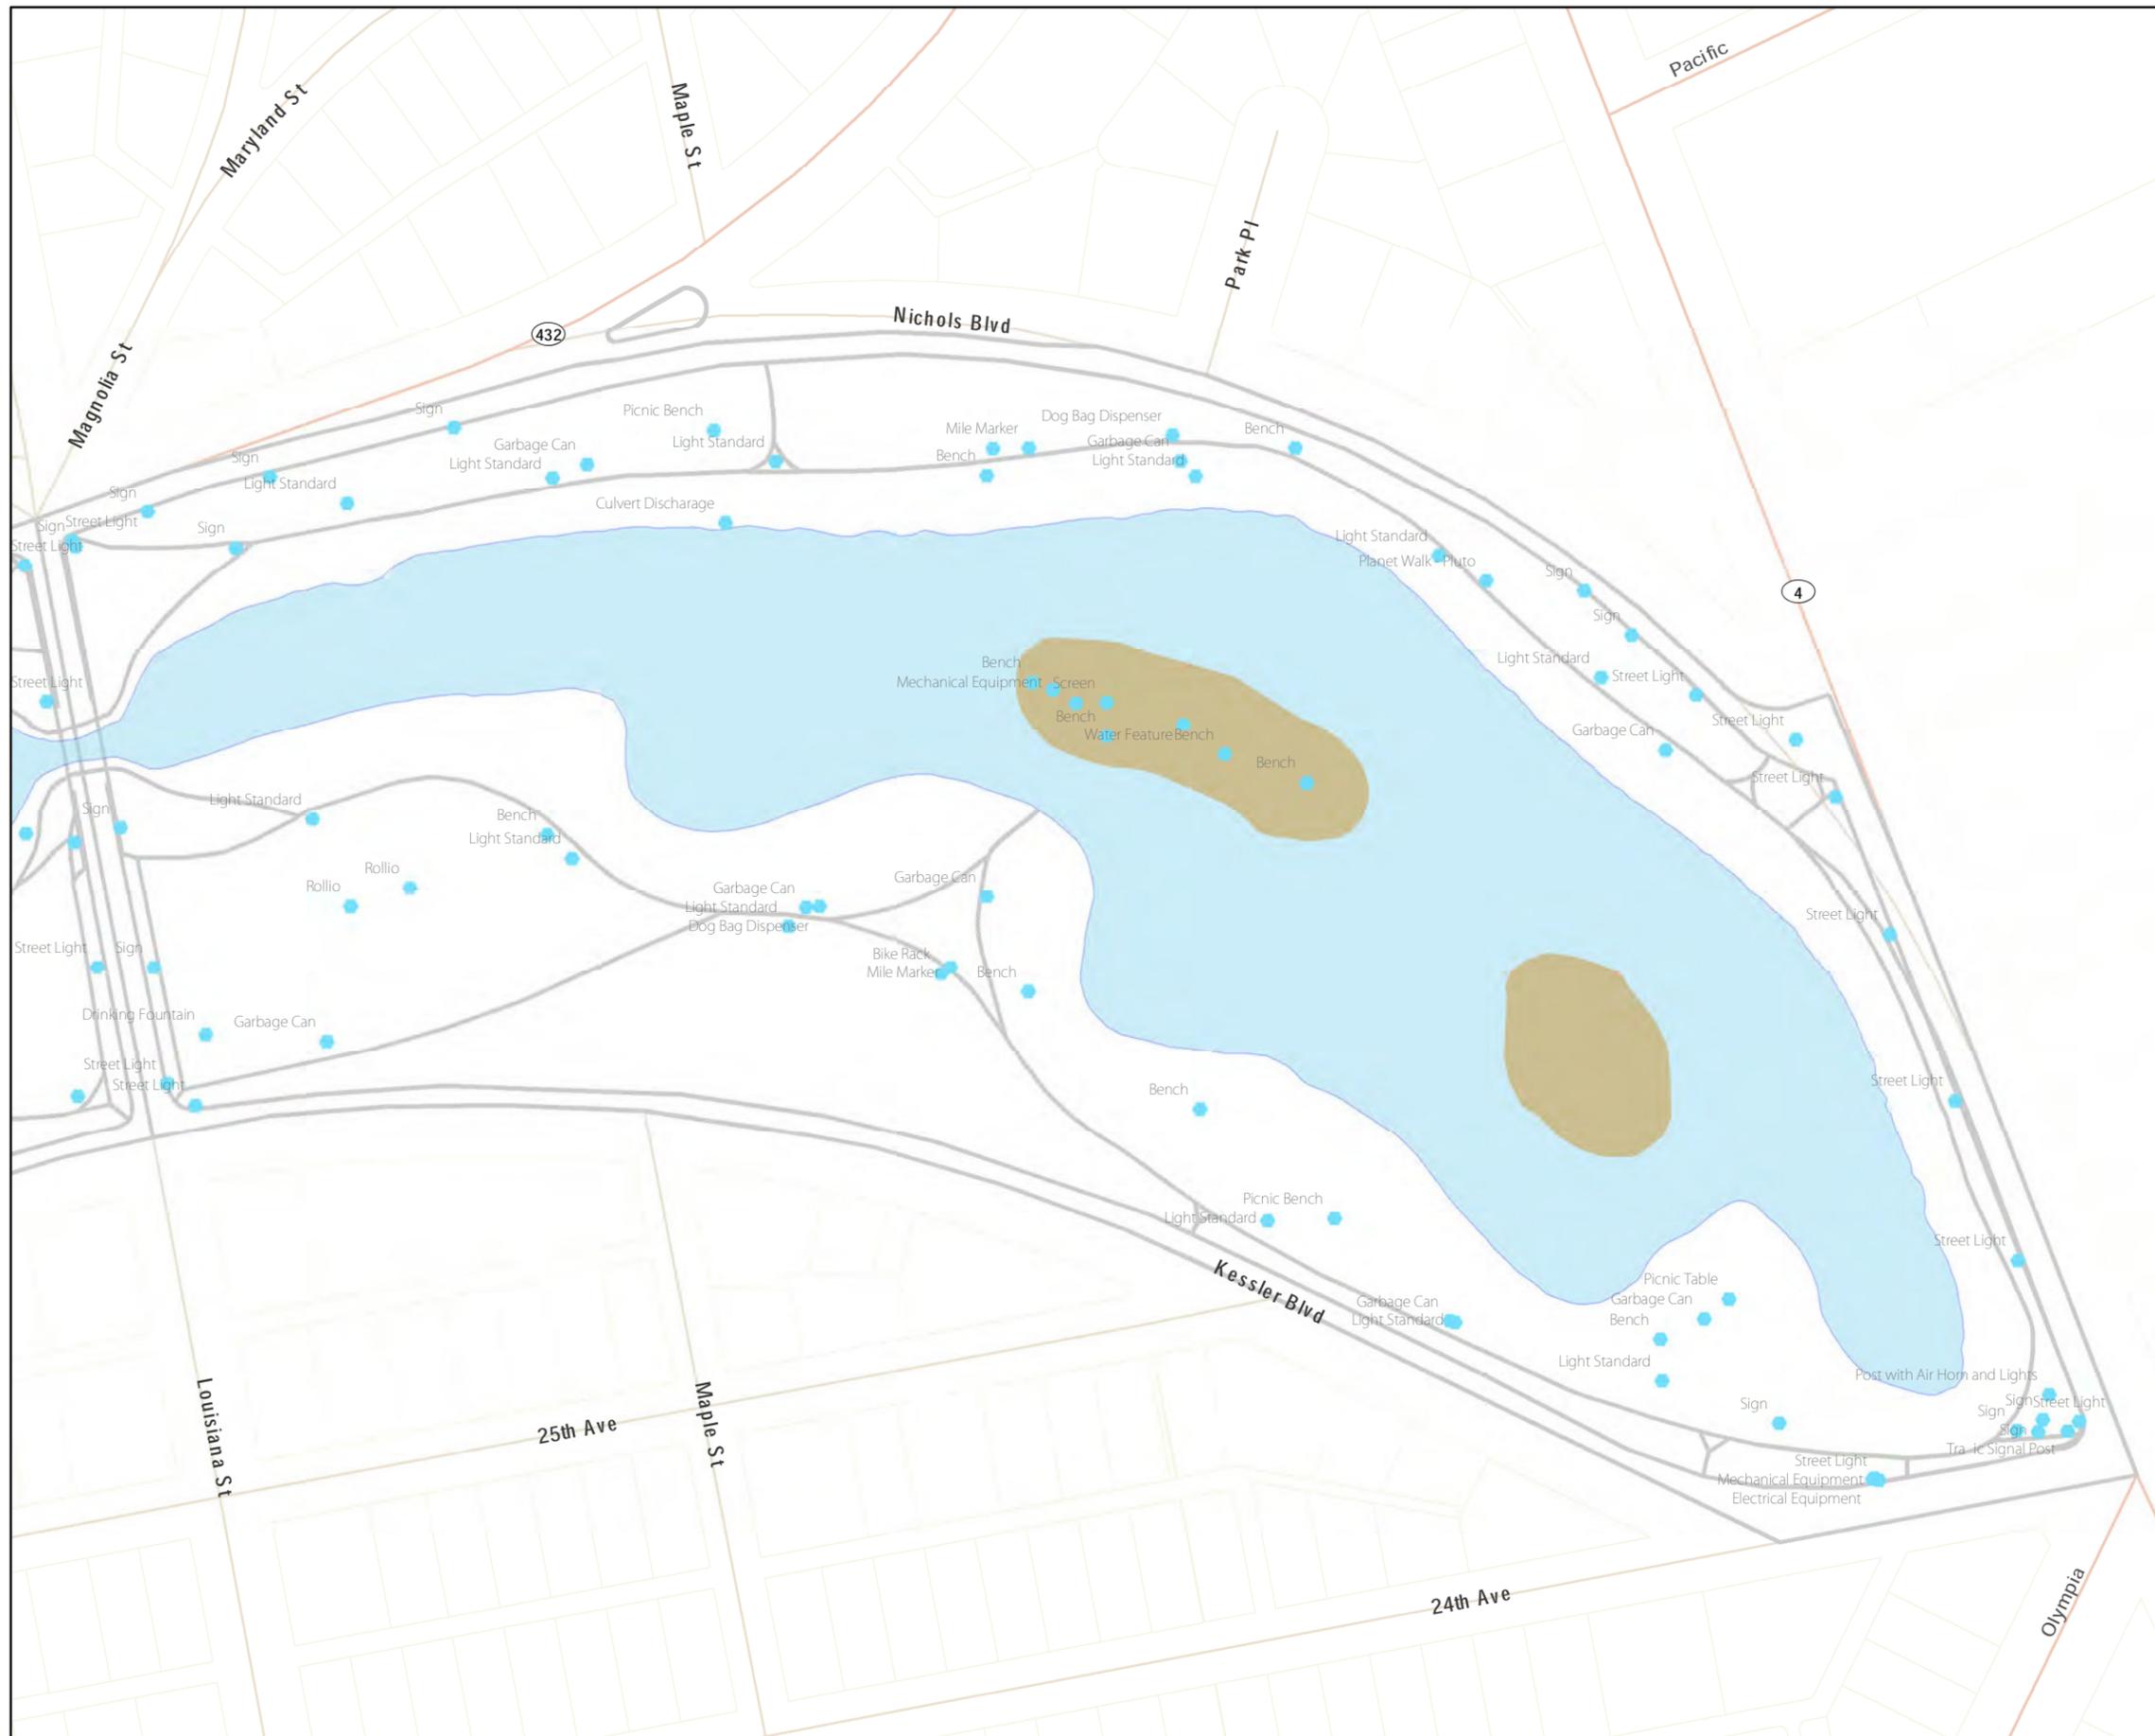
Section B

Status, Level, Condition

- Historic Non-Contributing, Minimal, Intact
- Non-Historic Non-Contributing, None, Intact

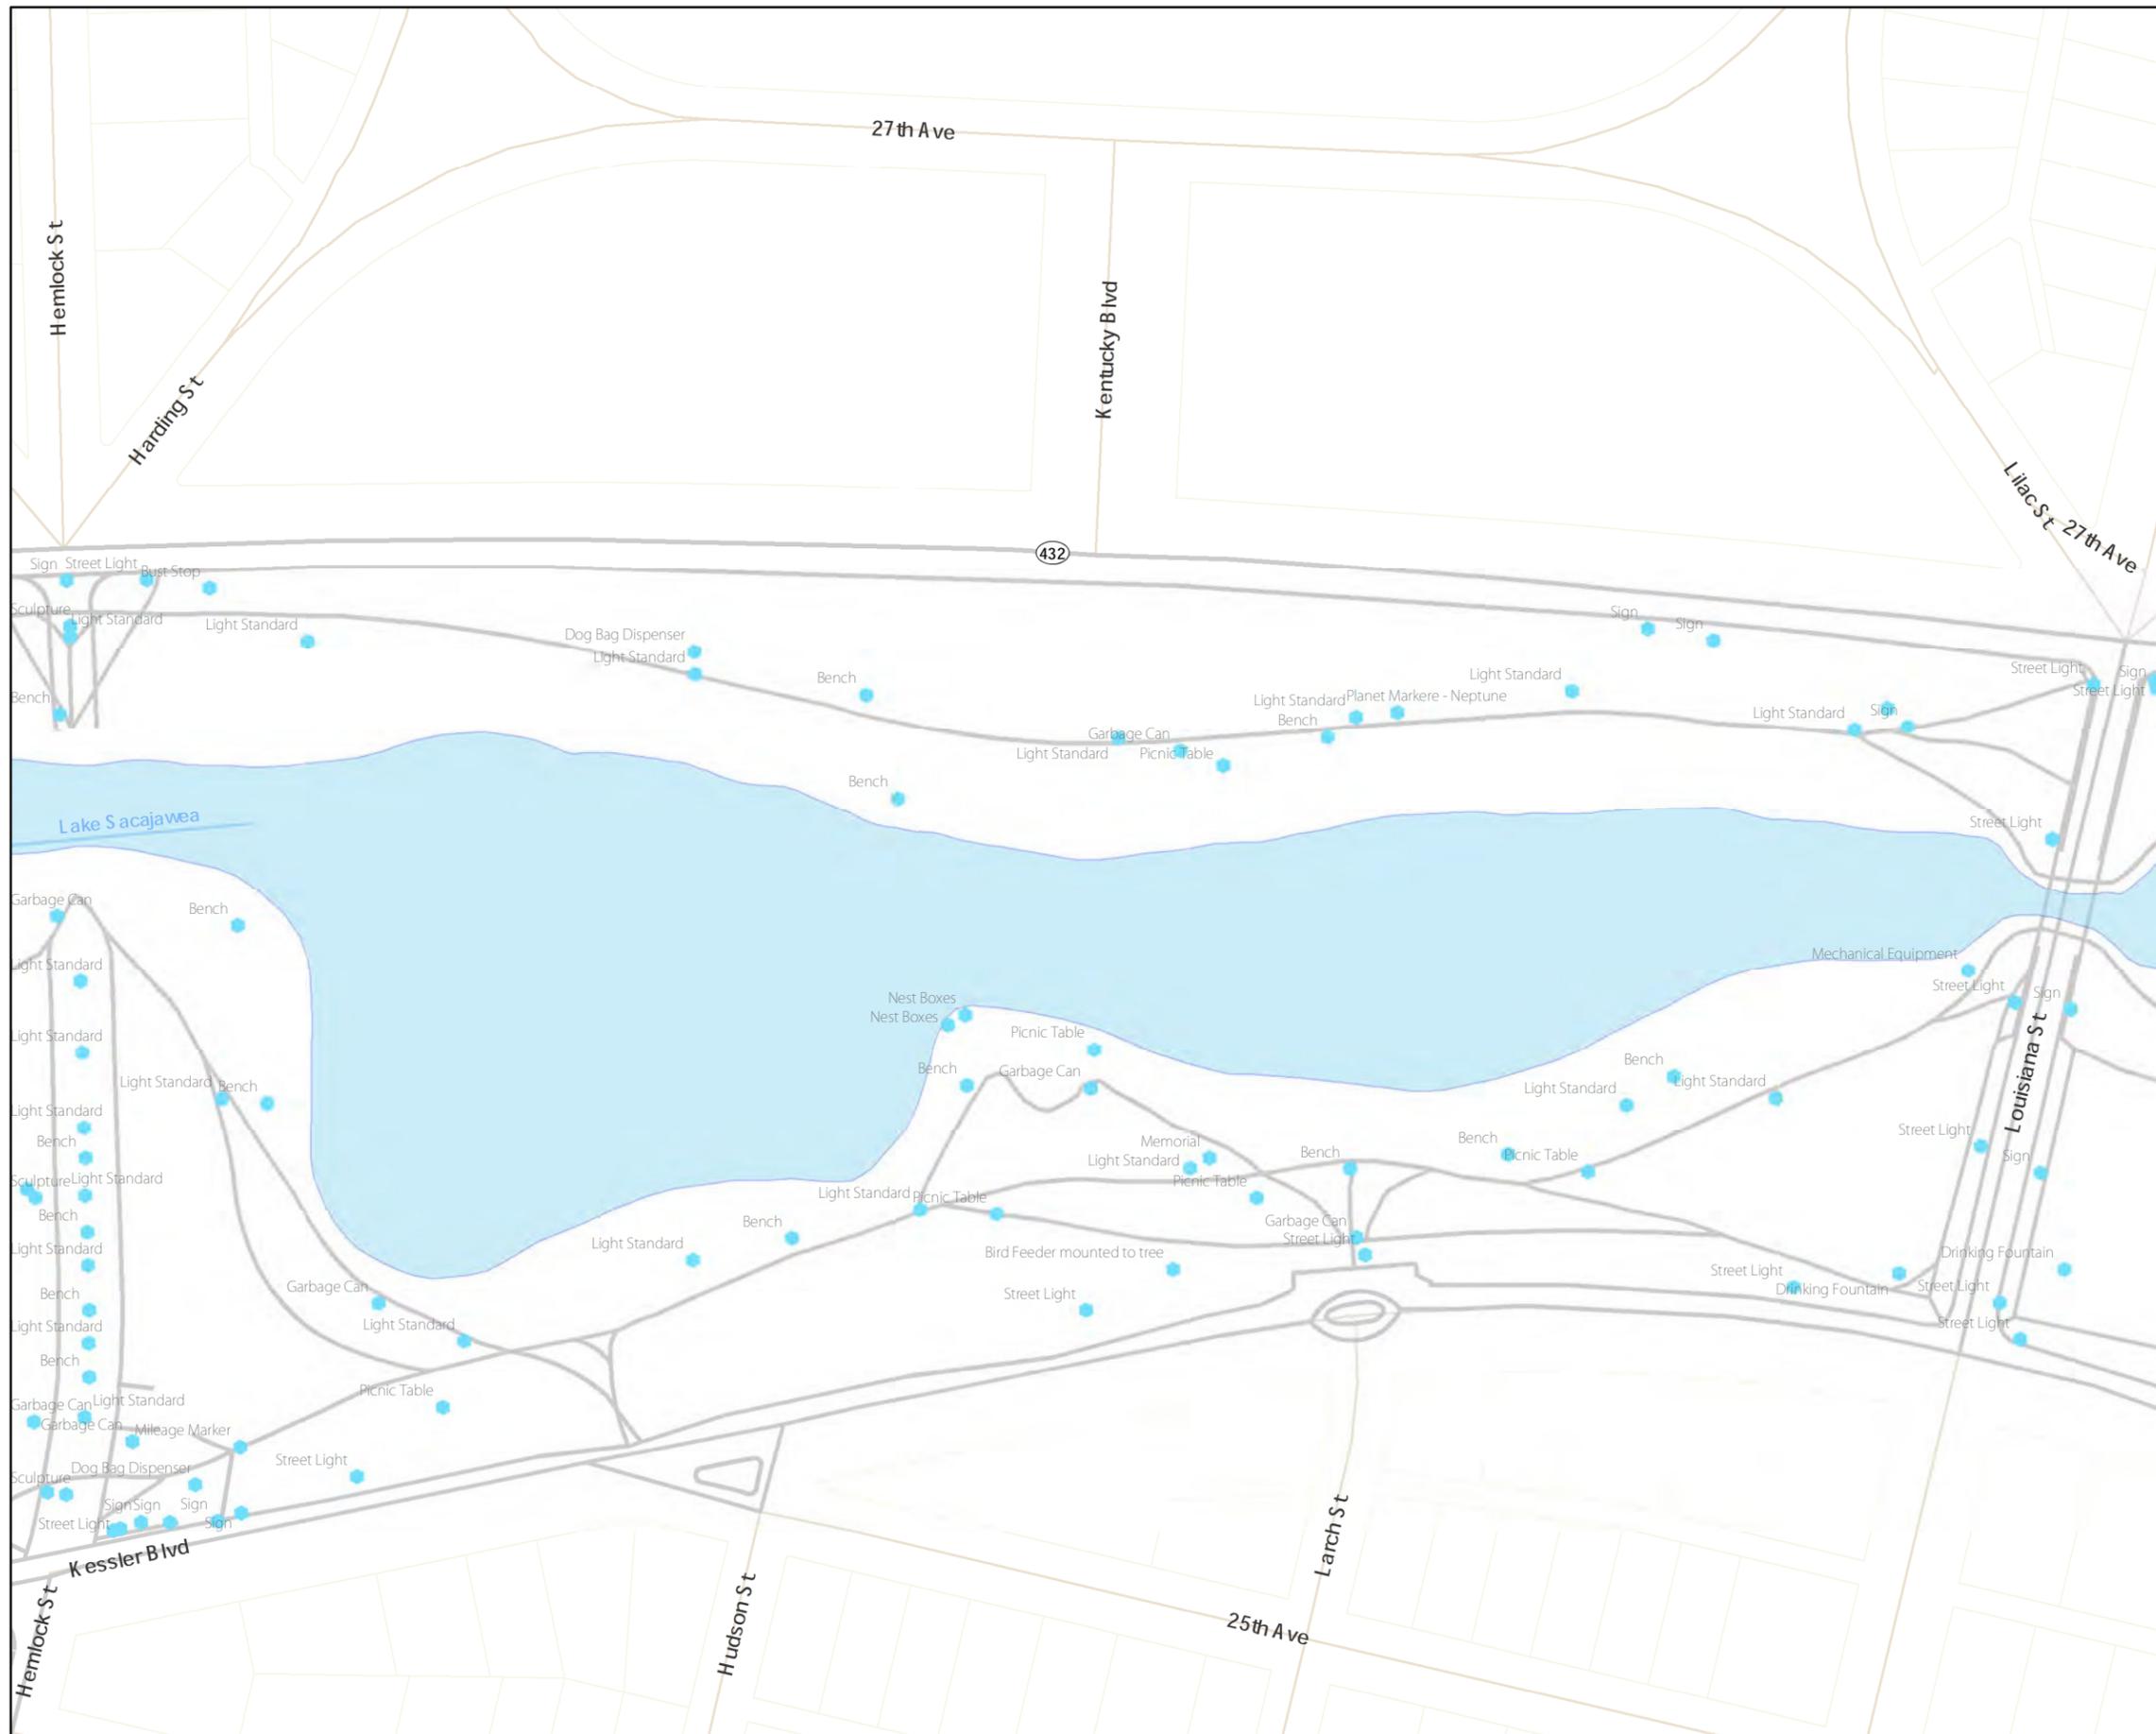
Section D

Status, Level, Condition

- Historic Non-Contributing, Minimal, Intact
- Non-Historic Non-Contributing, None, Intact

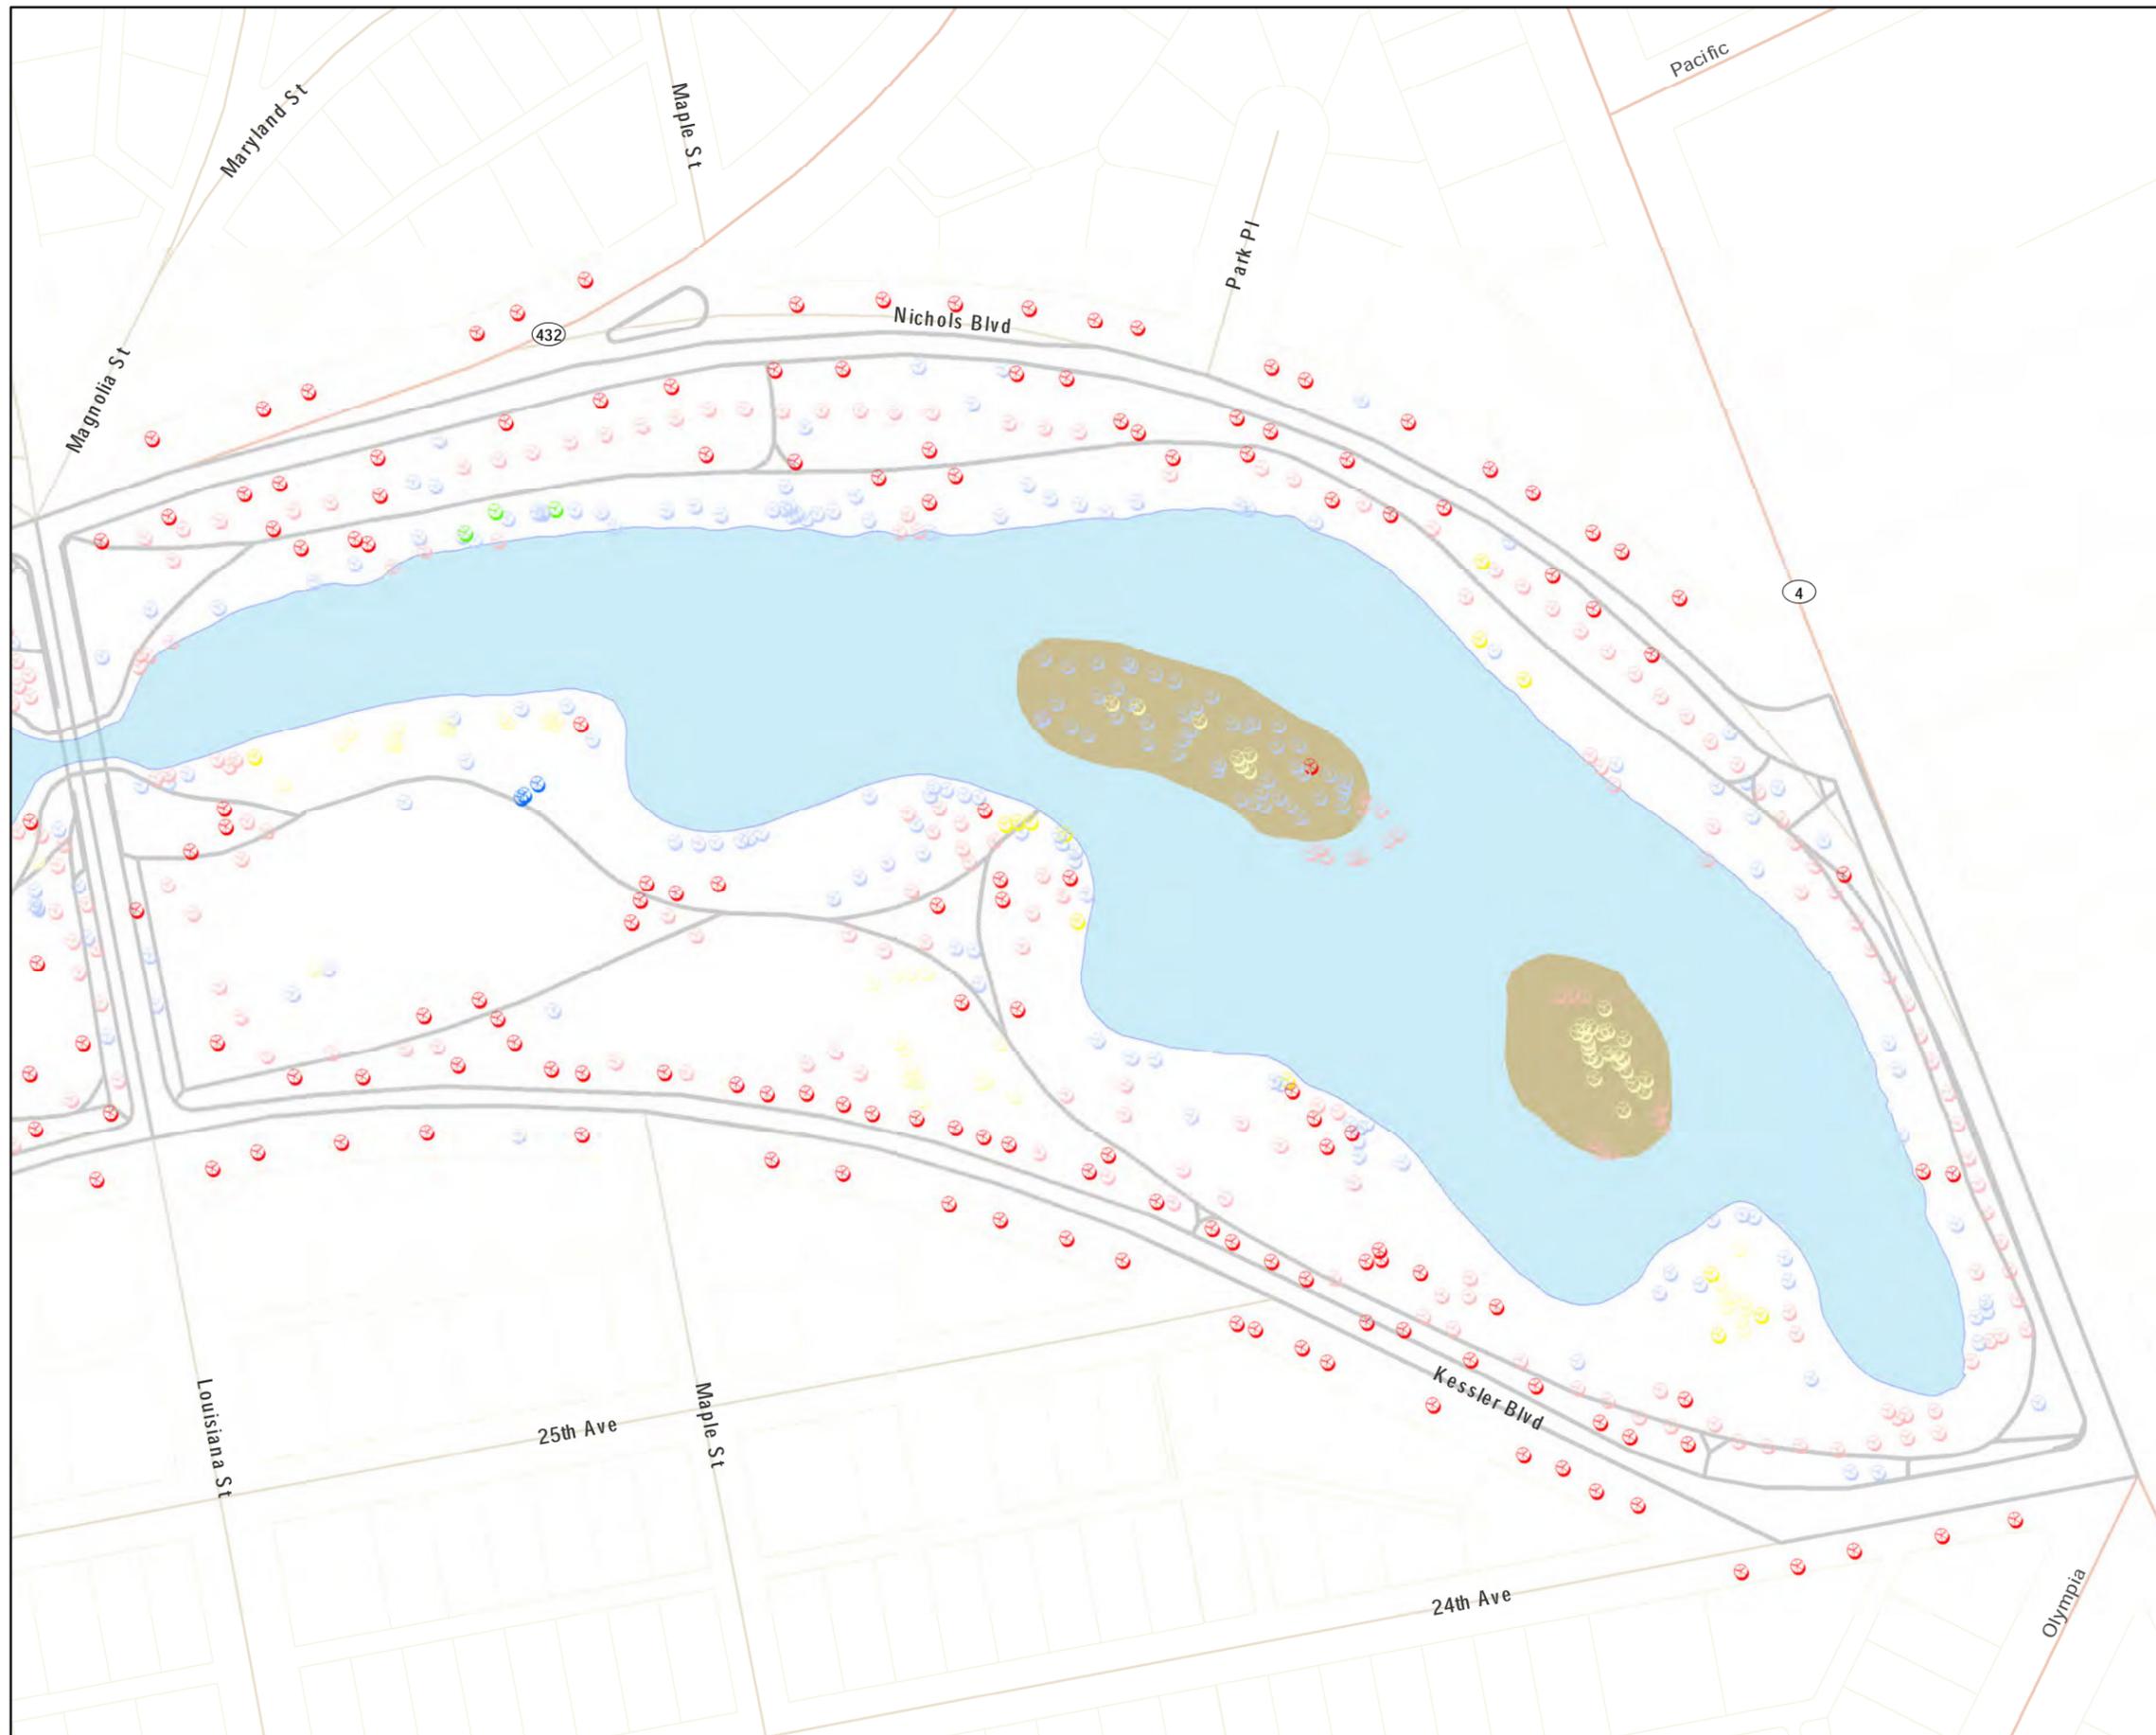
Section B

Status, Level, Condition

- Historic Contributing, Primary, Intact
- Historic Contributing, Primary, Missing
- Historic Contributing, Secondary, Intact
- Historic Contributing, Secondary, Missing
- Historic Contributing, Minimal, Intact
- Historic Non-Contributing, None, Intact
- Non-Historic Non-Contributing, None, Intact
