EVALUATION

2.1 CONDITION ASSESSMENT

City of Longview Lake Sacajawea Park Preservation Plan

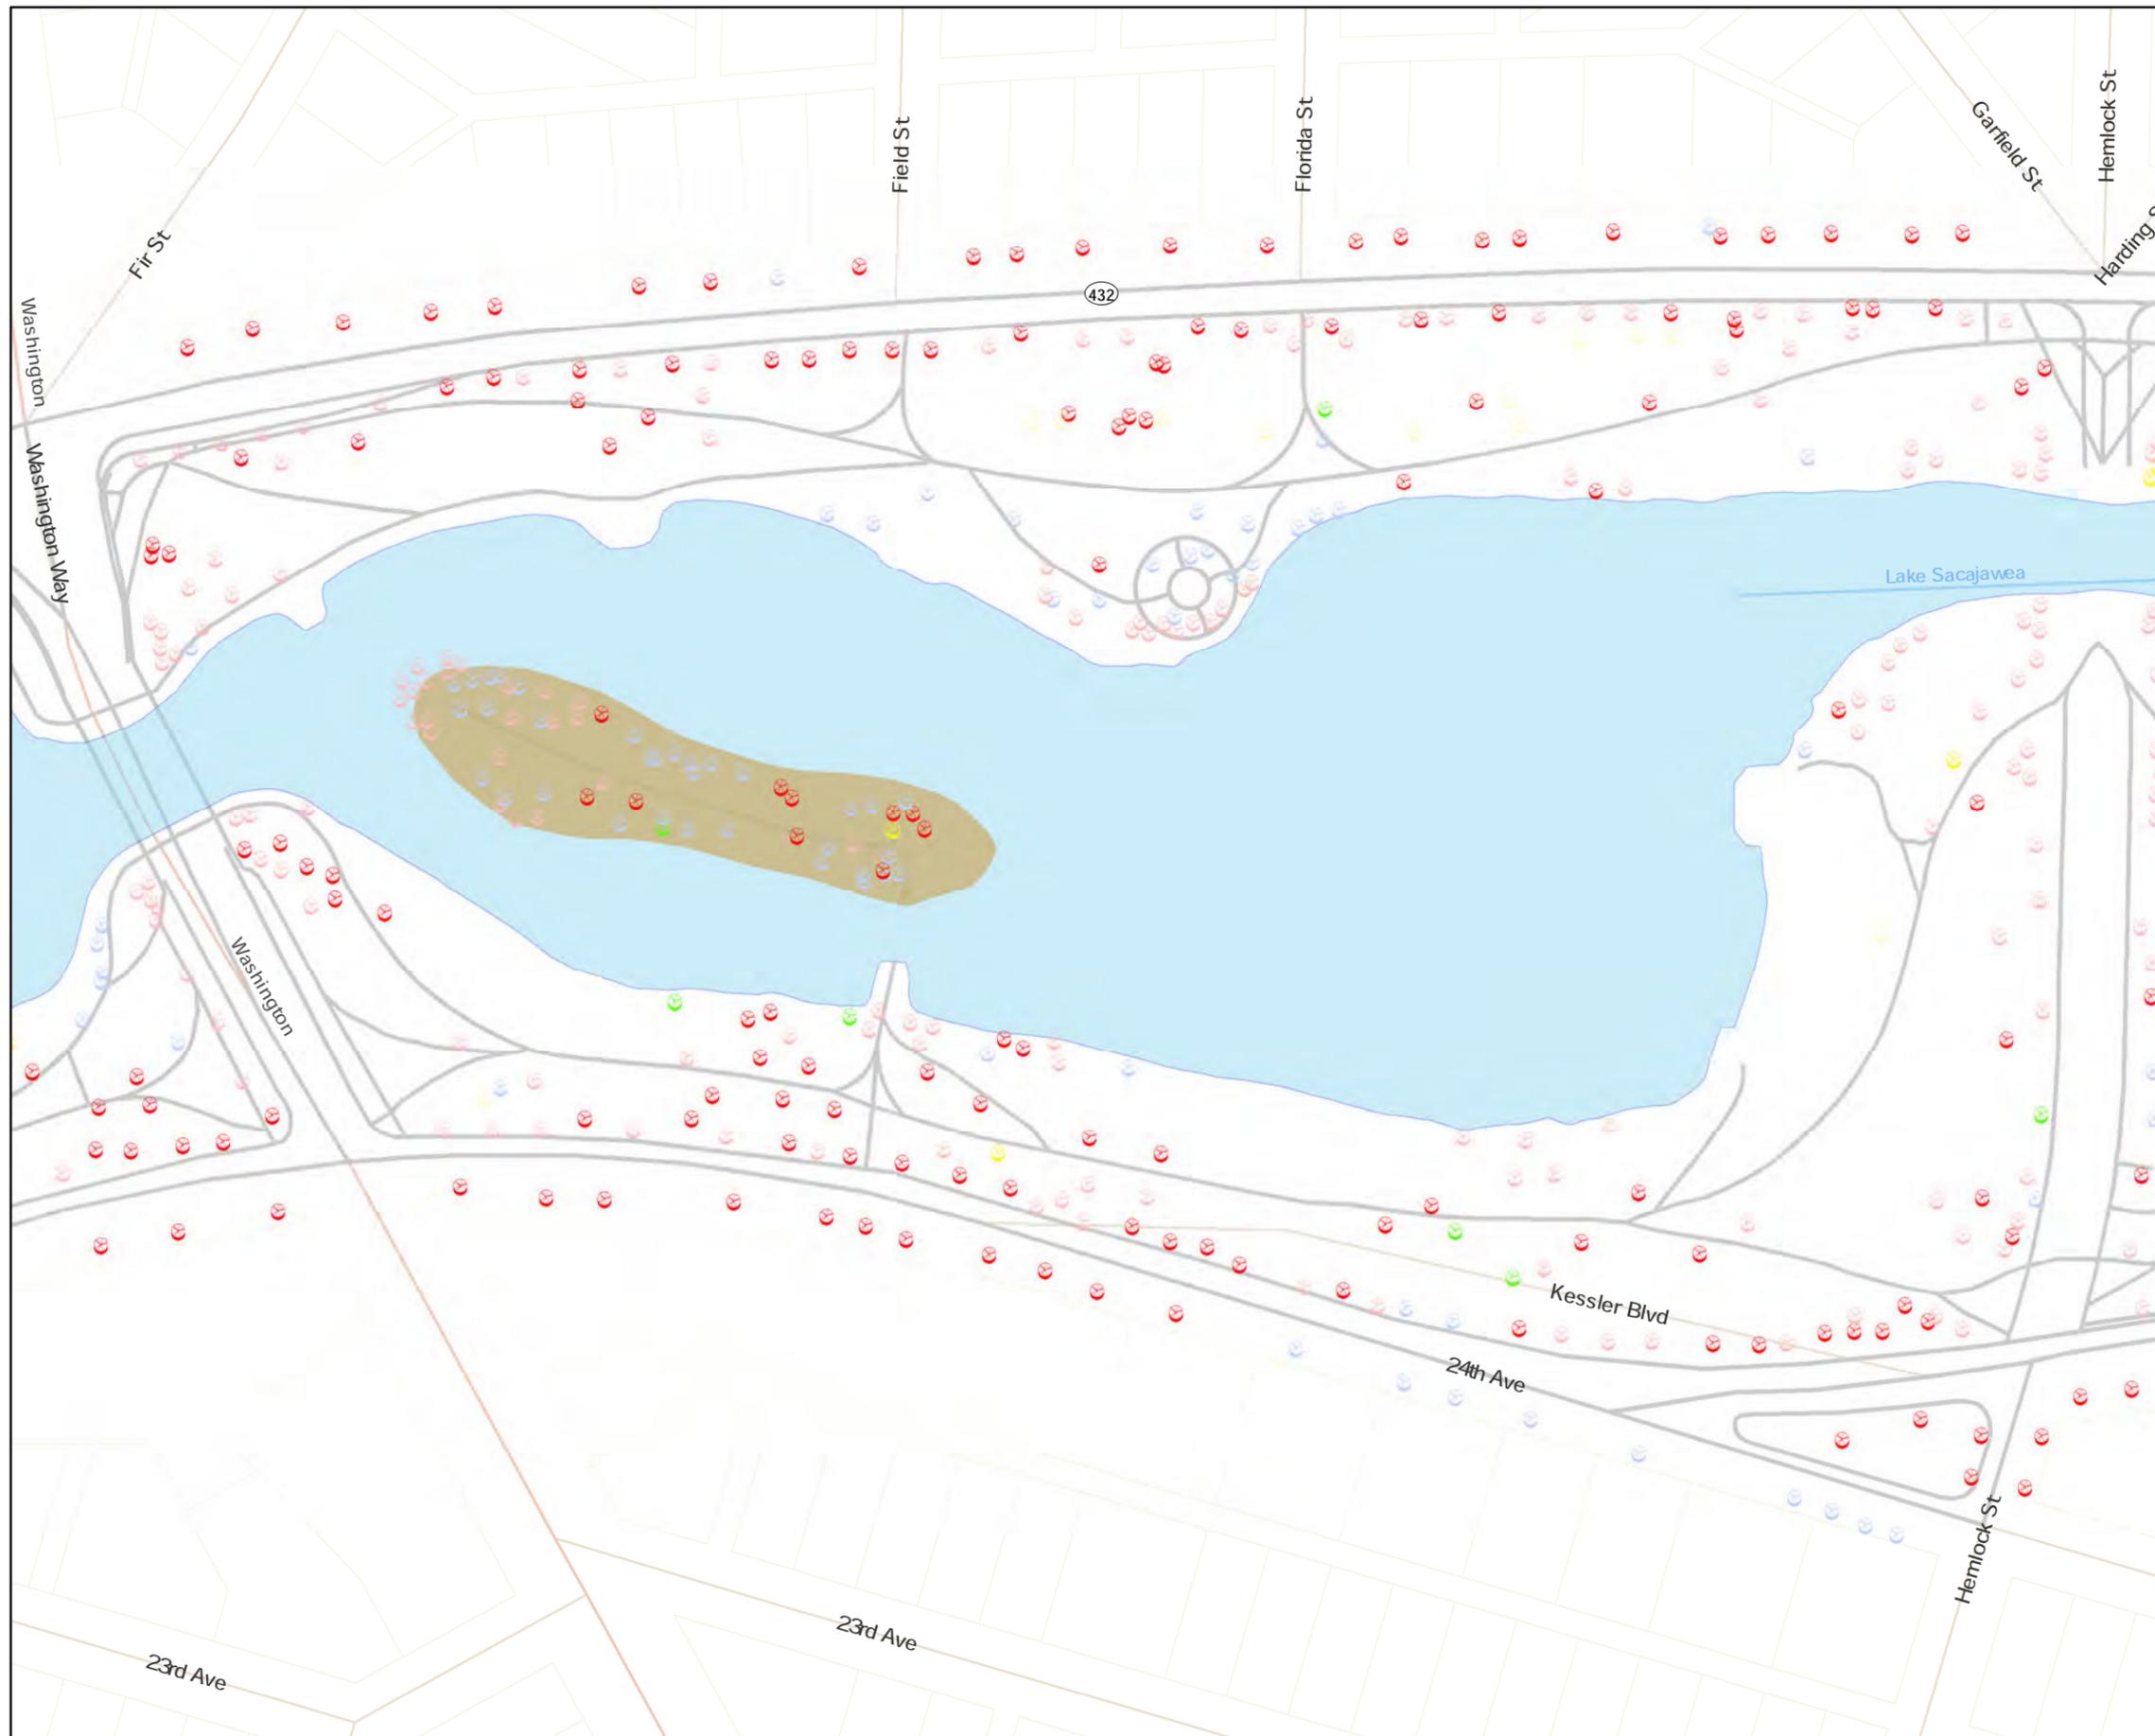
Section D

Status, Level, Condition

- Historic Contributing, Primary, Intact
- Historic Contributing, Primary, Missing
- Historic Contributing, Secondary, Intact
- Historic Contributing, Secondary, Missing
- Historic Contributing, Minimal, Intact
- Historic Non-Contributing, None, Intact
- Non-Historic Non-Contributing, None, Intact

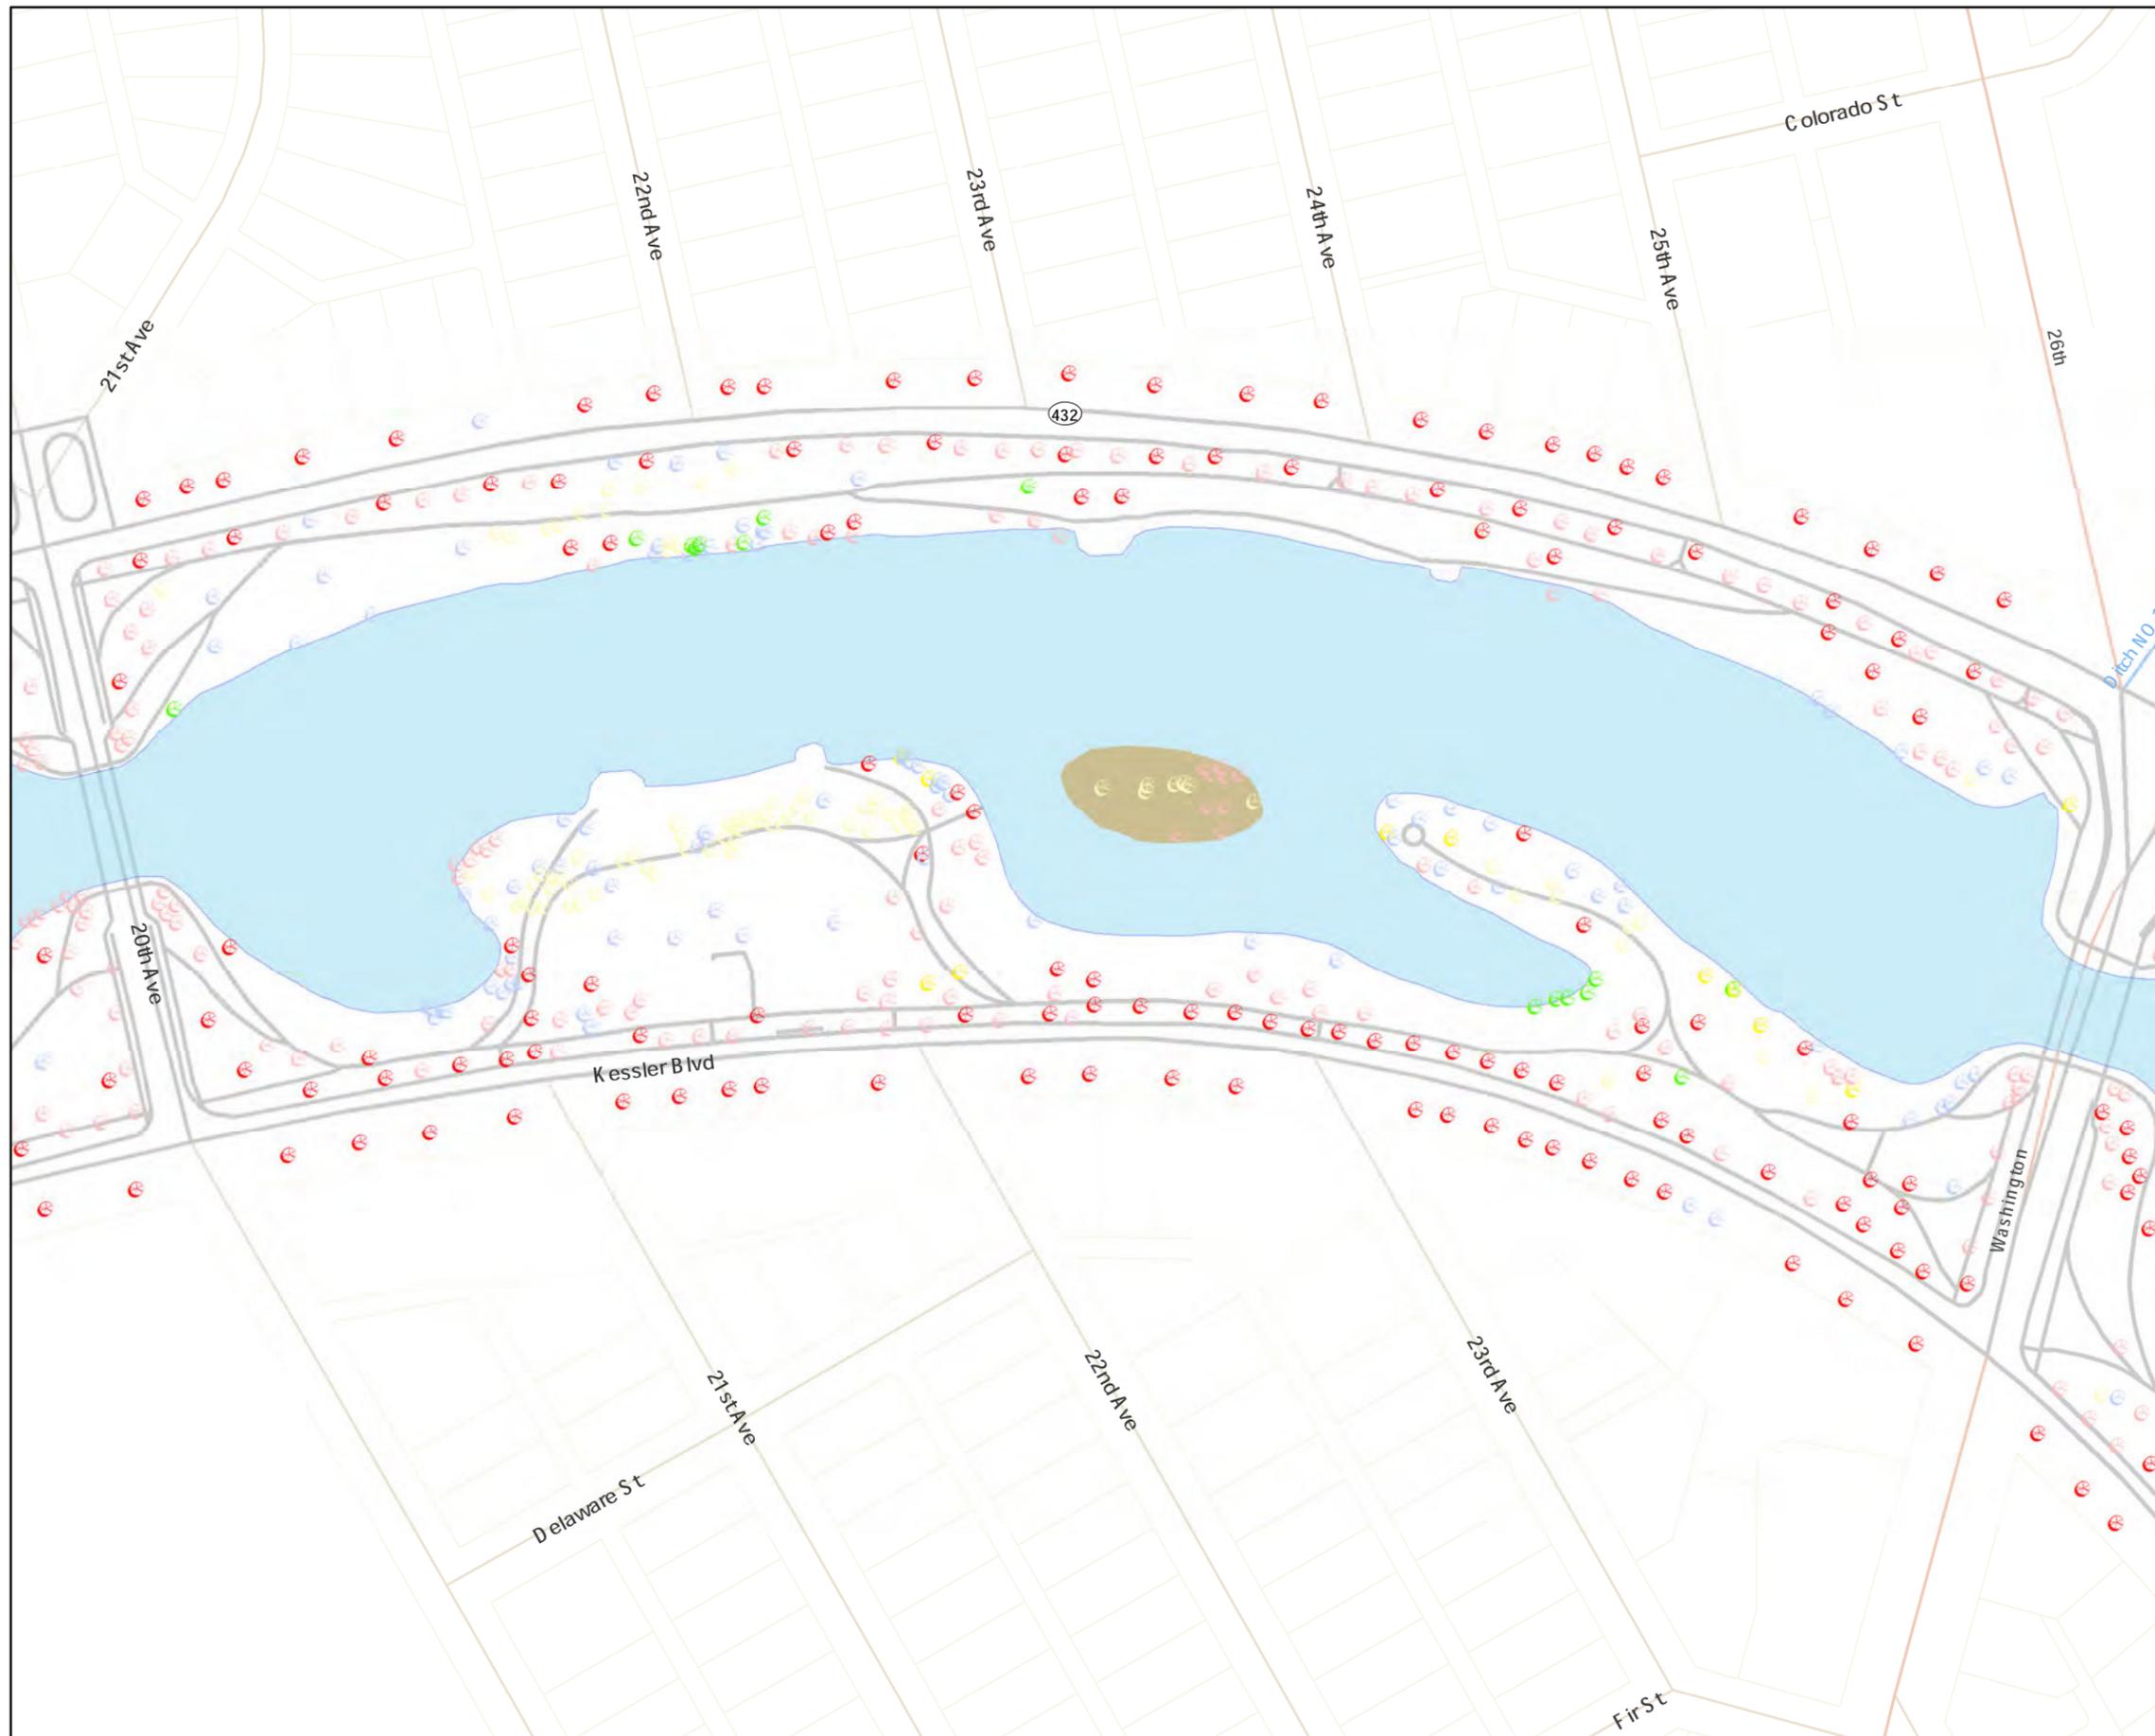
Section E & Sunken Garden

Status, Level, Condition

- Historic Contributing, Primary, Intact
- Historic Contributing, Primary, Missing
- Historic Contributing, Secondary, Intact
- Historic Contributing, Secondary, Missing
- Historic Contributing, Minimal, Intact
- Historic Non-Contributing, None, Intact
- Non-Historic Non-Contributing, None, Intact

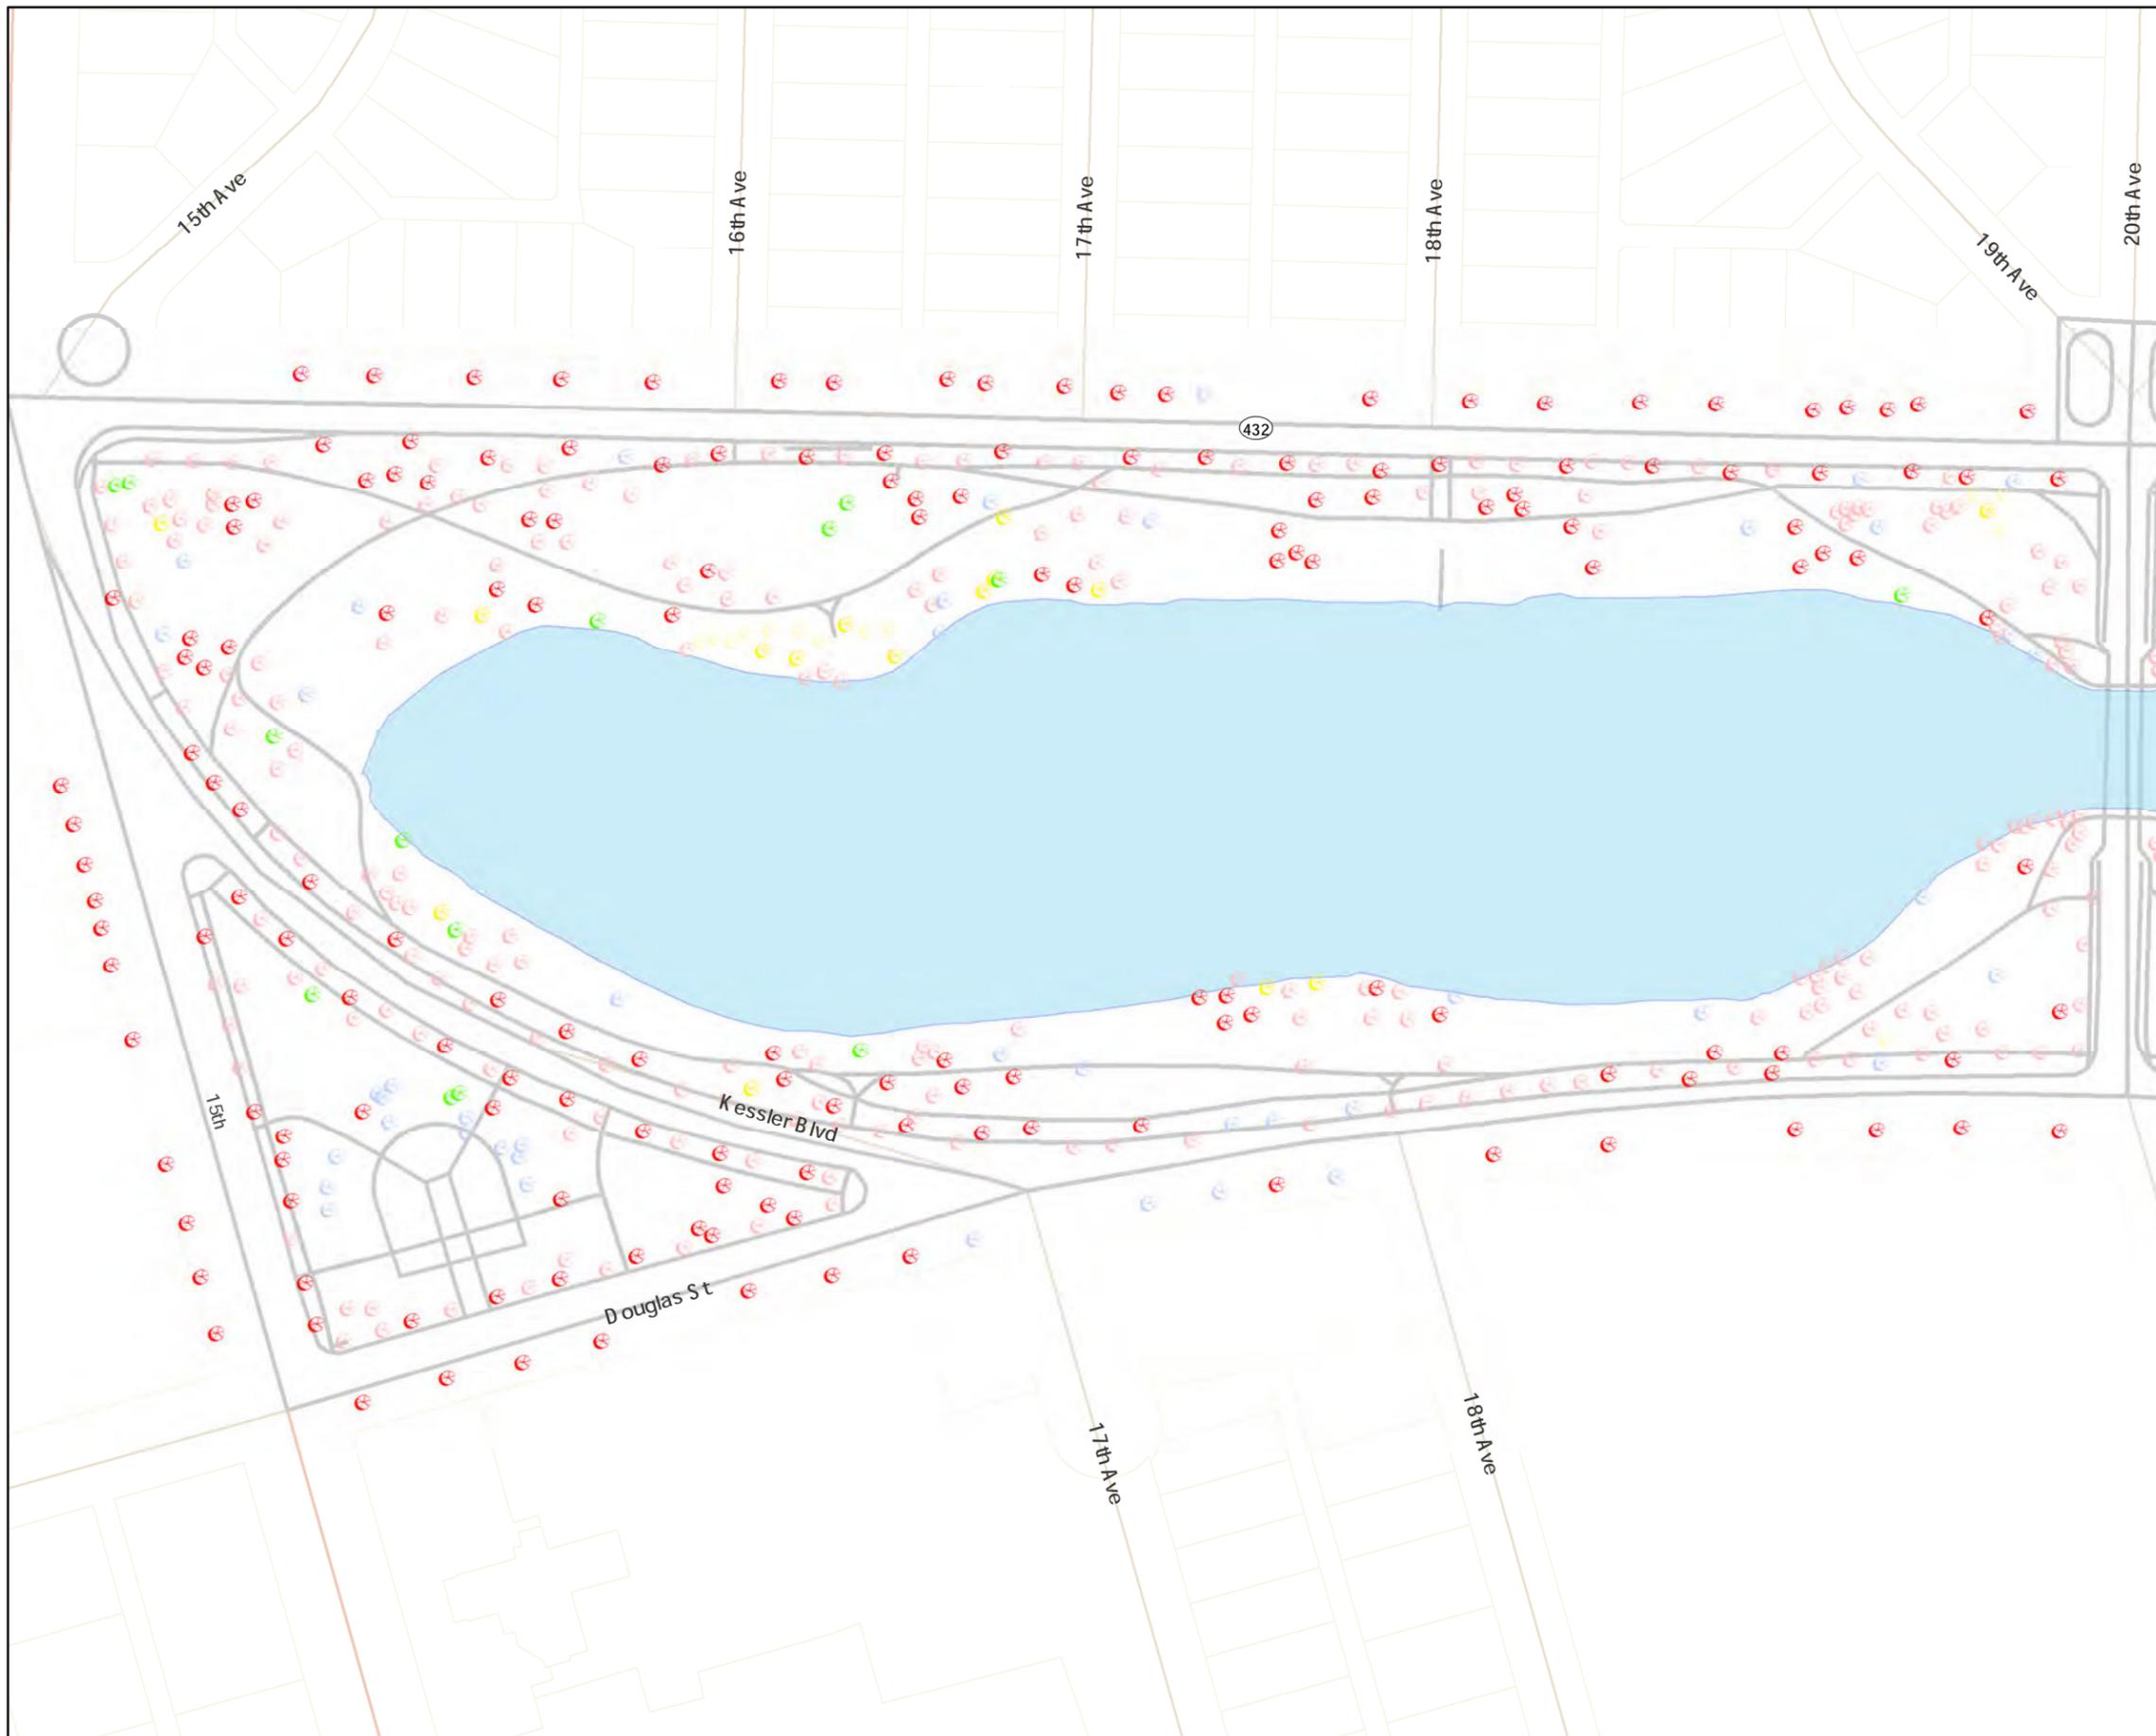
Status, Level, Condition

- Historic Contributing, Primary, Intact
- Historic Contributing, Primary, Missing
- Historic Contributing, Secondary, Intact
- Historic Contributing, Secondary, Missing
- Historic Contributing, Minimal, Intact
- Historic Non-Contributing, None, Intact
- Non-Historic Non-Contributing, None, Intact
