Longview Regional Water Treatment Plant Constructibility Study

The City of
Longview
Washington

May 7, 2008

Kennedy/Jenks Consultants
Engineers & Scientists

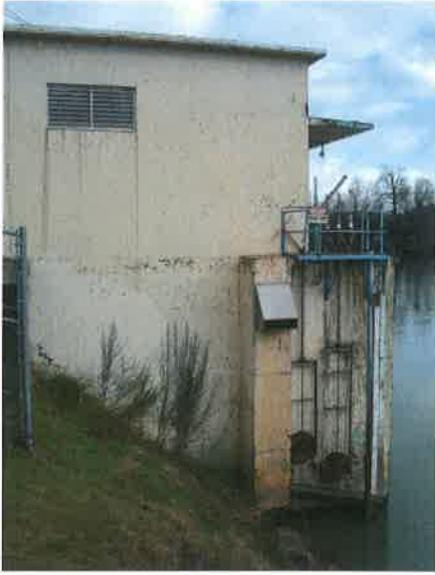
Photo No. 1 – Intake and Pump Station

The river intake and pump station are reinforced concrete structures with the exception of the additional electrical room on the northern side of the pump station, which is a concrete masonry unit block bearing wall structure. Kennedy/Jenks Consultants observed the concrete of the intake from the exterior, and it appeared to be in adequate condition; however, extensive cracking was observed on the southern wall of the intake during the site visit (Photos 1 through 3). Both craze cracks and pattern cracking were observed on the southern side of the structure. Hairline cracking was also observed at regular intervals along the height of the wall. The age of the structure, the condition of the concrete, and the exposure of the reinforcing steel all contribute to continued deterioration of the structure with increasing size of cracks, size and number of spalls, and required repairs of the structure. It is unlikely that the intake and pump station would meet current building codes for soil and earthquake loading.

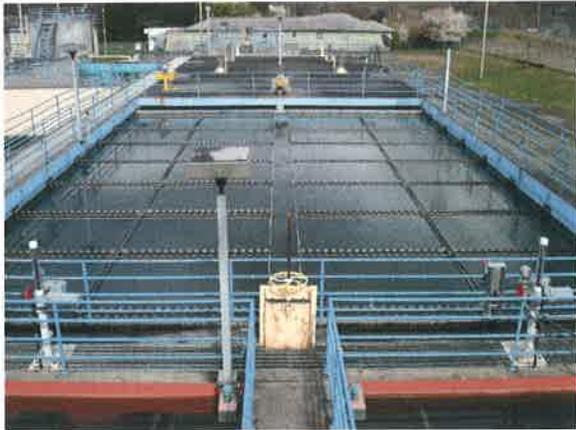
Photo No. 5 – Flocculation/Sedimentation Basin 1 (East)

Basin 1 was constructed as part of the 1979 expansion. Extensive cracking and some leakage were observed on the eastern side walls of both the flocculation (Photo 9) and sedimentation (Photo 6) basins. Vertical cracks were observed at regular intervals of 4 to 6 feet (Photo 10), portions of the cracks had spalled (Photos 7 and 8), and there was evidence of previous attempts to repair the cracks. Efflorescence in the cracks was also evident (Photo 11). Efflorescence is the deposit of salts, usually white, that forms on the surface after the salt has emerged from solution from within the concrete. Evidence indicated that the cracks have led to corrosion of the reinforcing steel in the walls; corrosion stains (Photo 10) were noted on the walls of the flocculation basin.

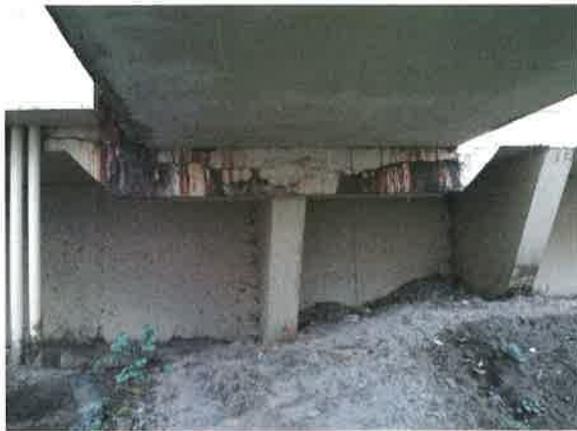
Photo No. 13 – Flocculation/Sedimentation Basin 1

Kennedy/Jenks Consultants observed extensive cracking, spalling, and some leakage in the walls of the basin. Extensive cracking and spalling were observed beneath and along the sides of structural corbels supporting the channel that connect Basins 1 and 2 (Photos 13, 14 and 15). Extensive cracking, spalling, and leakage were also observed in the walls of Basin 2 (Photos 17 and 18).
